Willamette # 7 Work Party Notes

Historic Museum Fort Missoula, Missoula, MT

6/8/19 to 6/12/19 - # 2 – 2A

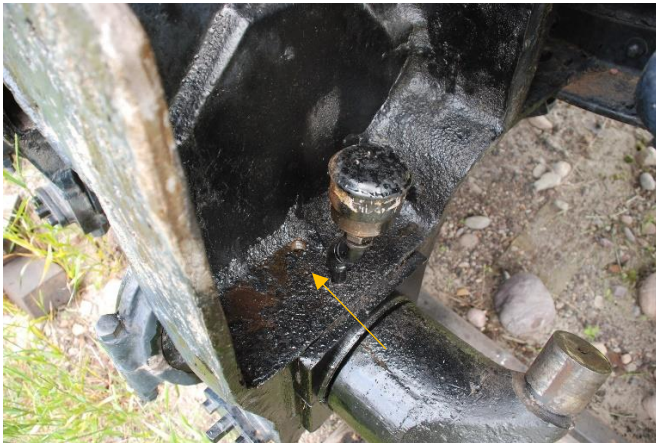
Weather was a bit unsettled so we had a little less of a turn out than expected. Started to work on valve gear part by removing links and pins for cleaning. Added additional grease to crank shaft bearings and noted that it was starting to flow into the galleys. Remove oil cup on # 1 cylinder (previous work party), made new cover for oil cup that had been missing.

Location of Missing Oil Cup on # 1 main

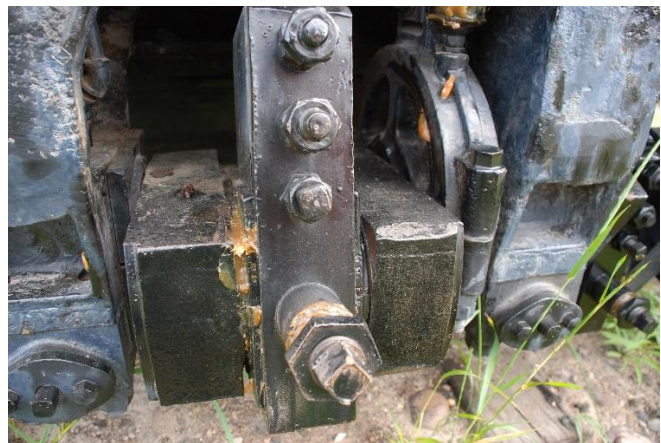
Crank Shaft taking Grease

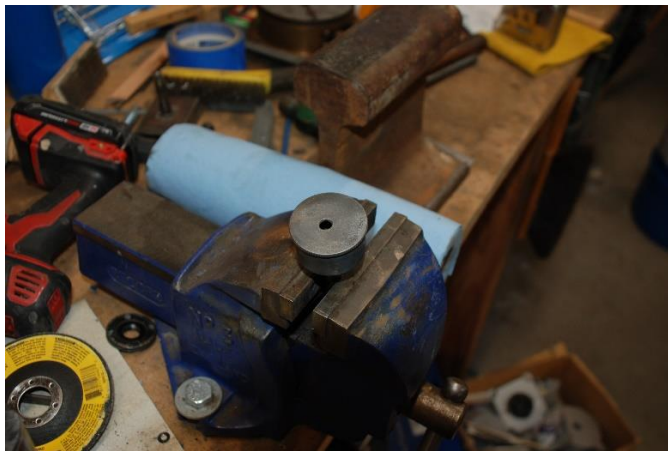
Removed links from Tumbling Shaft, loosen bolts on Shaft bearings, and reconnected to Johnson Bar (had been disconnected at some time in the past). This allowed Johnson Bar and Tumbling Shaft to move freely as intended. Removed all Oil Cups from Tumbling Shaft (4 Total) all were missing parts or damaged beyond use. Identical replacements are available from several sources new. It would appear that Anaconda filled the cups with Wool Waste and drilled a 1/4" hole in the top for easy service/oiling. This is the case on all of the oil cups on the locomotive.

Oil Cup with hole (typical)

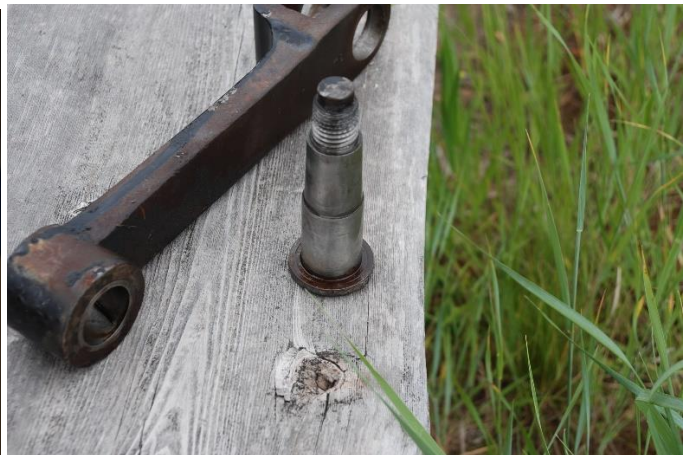
Link and Pin after removal

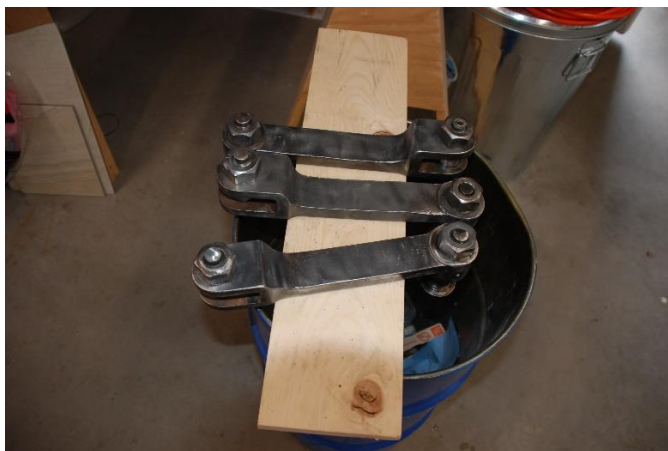
Cleaned Links ready for installation

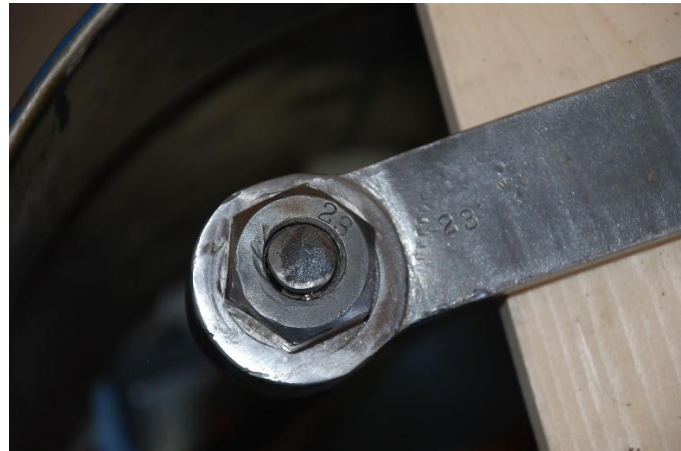
We removed all of the links for inspection and cleaning. Found that all parts are well numbered by Willamette during construction, and renumbered during its life by Anaconda. In the case of the pins and a number of bolts this is very important as that are "tapered" fit and appears that all of the nuts are "hand fit" to their threaded counterpart. All parts removed were inspected and cleaned for reinstallation (6/22/19). As in the past we found loads of sand (from previous sand blasting operation) in all openings, and care was taken to have it removed.

Willamette Numbering on Pin Nut and Rod

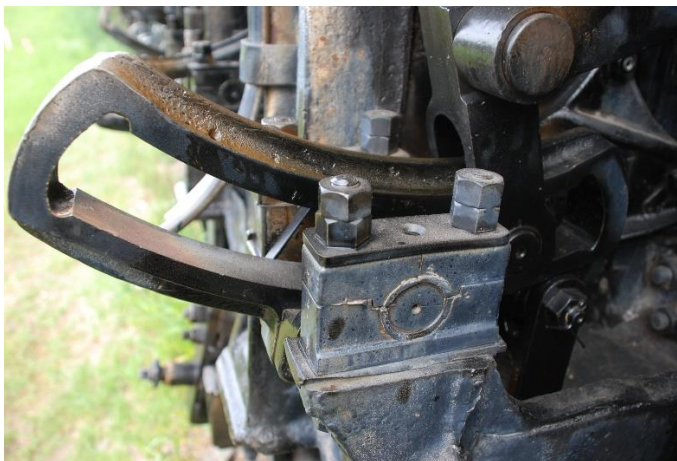
Link prior to taking apart and cleaning

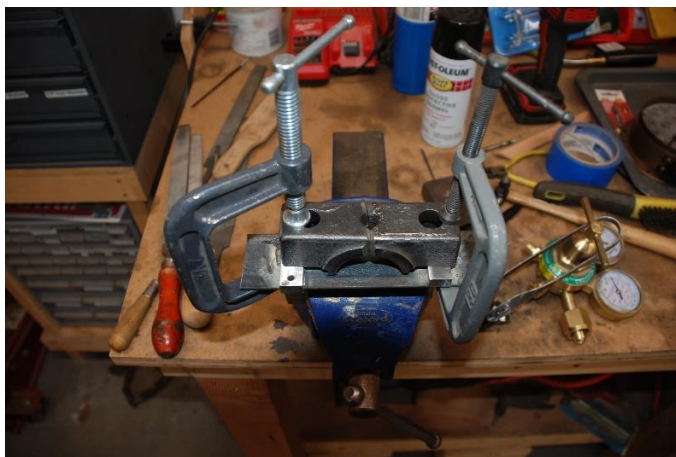
Caps were removed from rockers on the links, and cleaned and reinstalled. It was noted that several were broken but serviceable. This is very old damage, more than likely cause by a weak design in the cap. There is a notation in the Willamette spare parts ordered, that one link block and bearings was ordered in 1929 (Anaconda Ownership). Anaconda made straps to hold the bearing caps in place for 4 of the caps. One of the broken caps was "brazed" as per Anaconda practice, and 2 additional cap/straps were made.

Cap reading for brazing repair

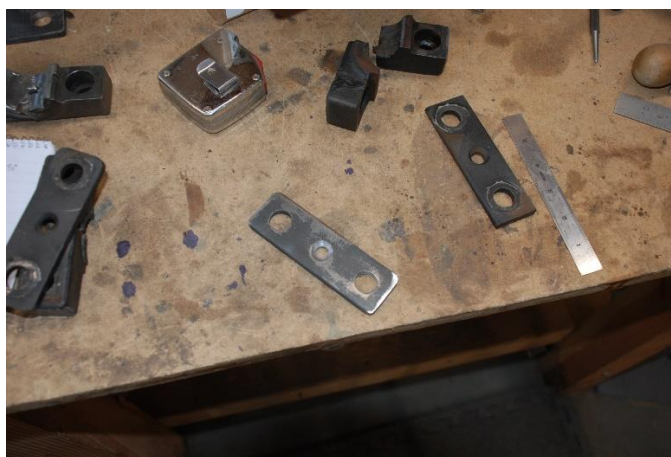
New plate for cap, Anaconda plate on left

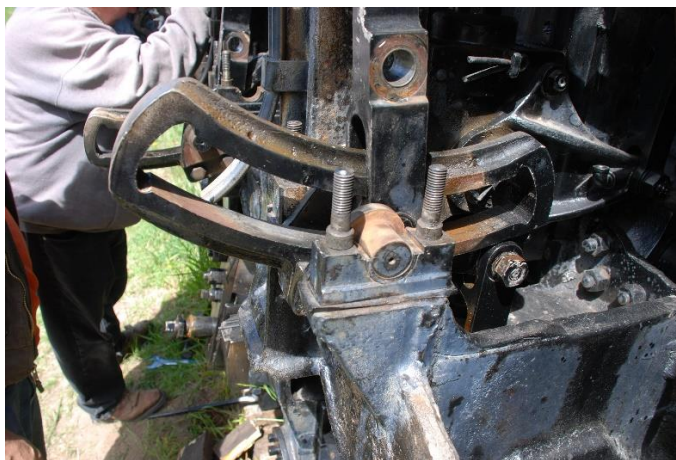
Link Block ready for cleaning cap removed

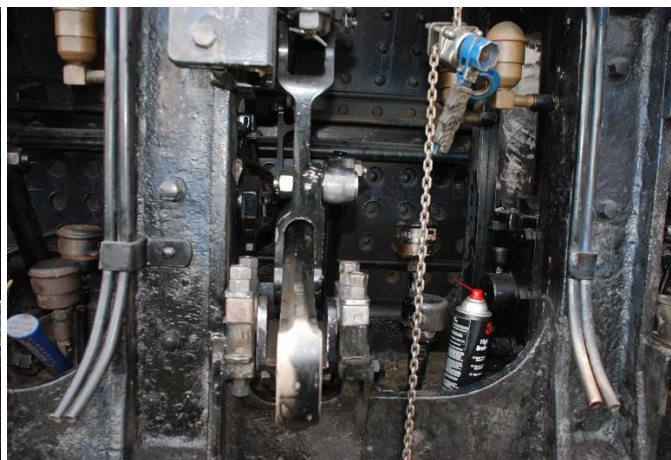
Link and blocks reinstalled after cleaning
