Willamette # 7 Work Party Notes

Historic Museum Fort Missoula, Missoula, MT

7/4,5,6/19 - # 4, 4A, 4B

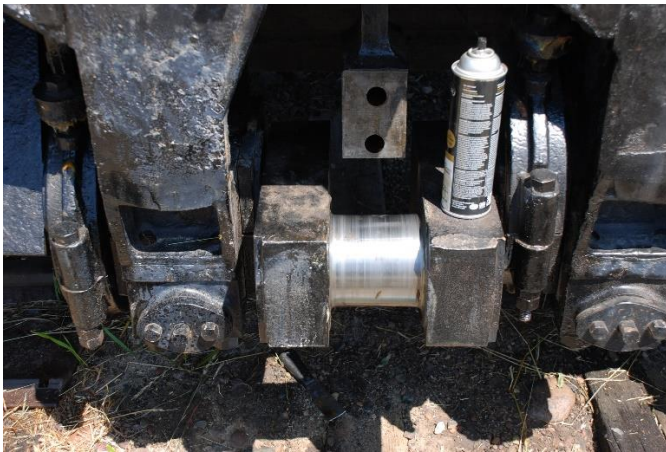
All three crank shaft rod journals (throws) were found to be in good condition, with distributed grease that we ran into them at a pervious work party, along with remnants of heavy grease (appeared to be “Pin Dope” or Hard Grease) from previous operations in the 1950’s. There was also some marking on the journals which was more like a staining from the earlier grease. The journals were cleaned, greased and covered to protect the surface.

Rod Journal on # 2 after bearing removal

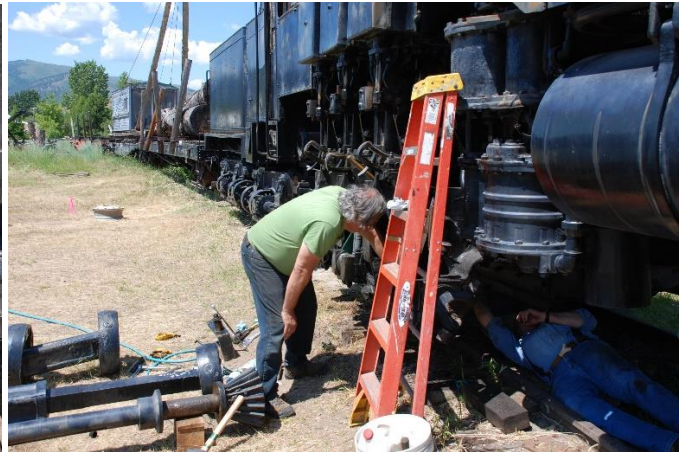
Mike and Bill removing cotter key from wedge

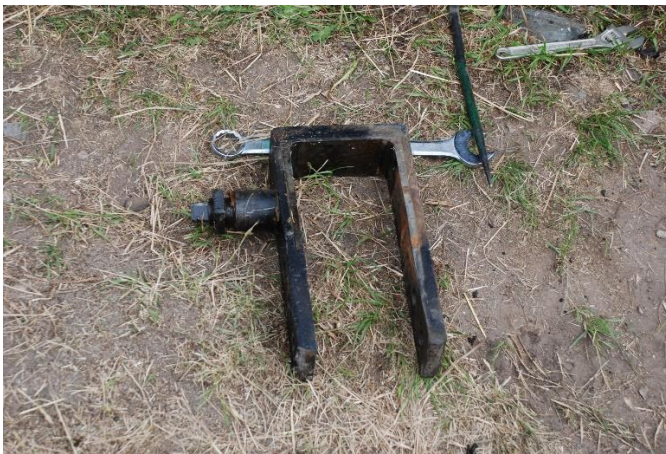
The straps were cleaned and will be wire wheeled to remove remaining paint and some minor rust. All old grease was removed from passages, and threads checked and cleaned on grease cups. # 1 crosshead was blocked up to prevent the rod from dropping onto the crank shaft. #’s 2 and 3 will clear the crank shaft.

Rod Brass Strap after removal

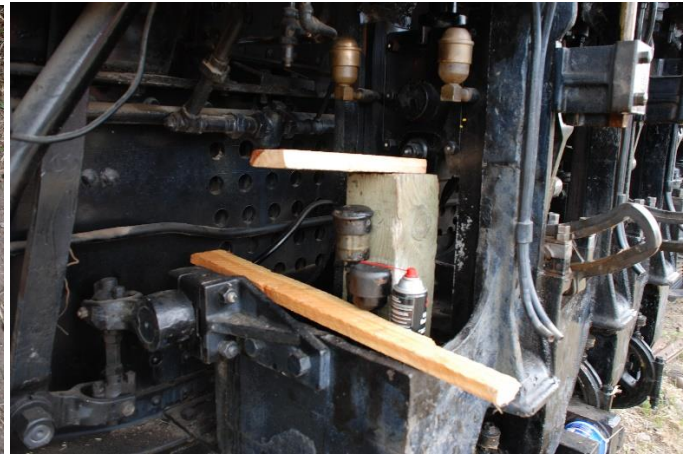
Crosshead supported during removal of brass

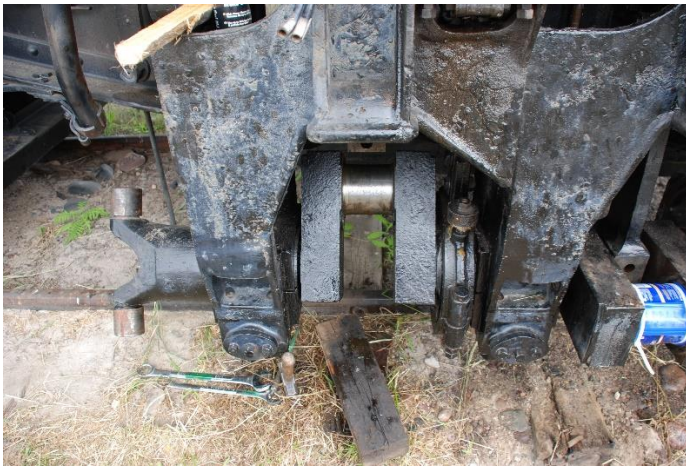
1 Crank Journal as found prior to cleaning

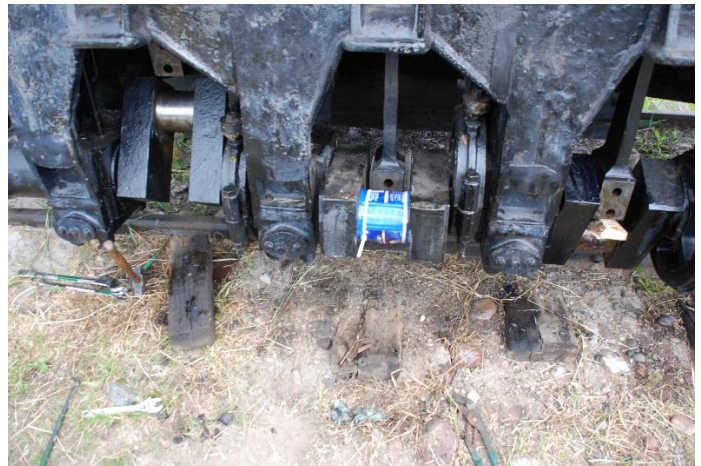
2 Journal with plastic sheet over it for protection

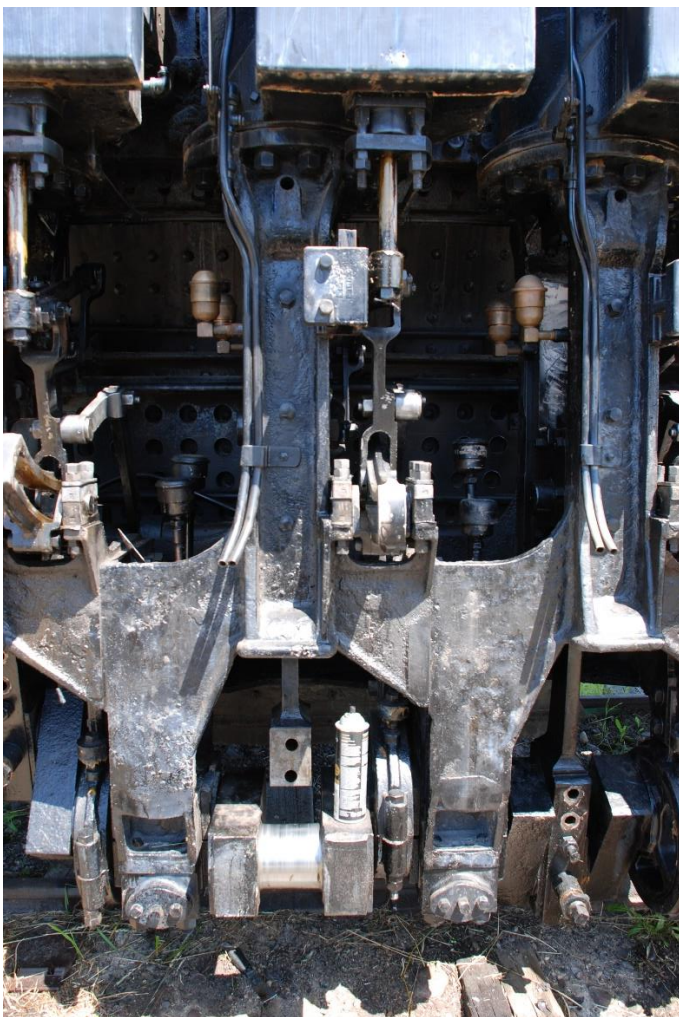
2 Overview of assembly

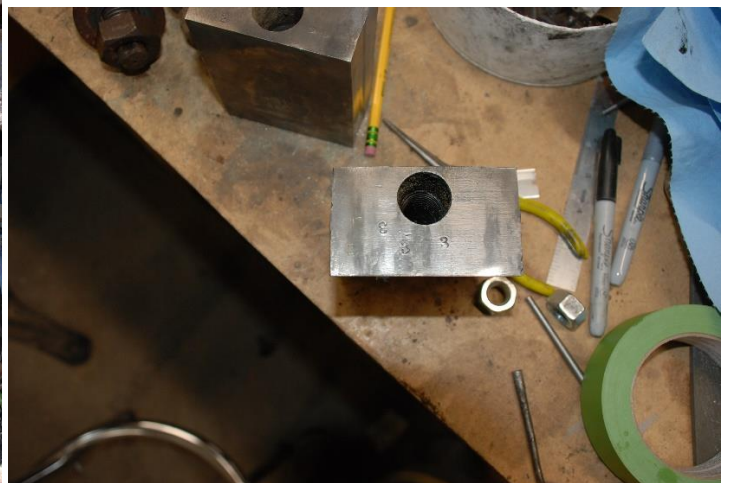
Parts removed for cleaning an inspection Tapered Rod Bolts, all brasses, 3 rod straps, 3 wedges including adjustment “bolts” and Jam Nuts and all shims for brasses. Cotter Keys removed will not be reused but replaced with new keys. Noted that wedges had multiple number marking as to position which appear to be from Willamette.

3 wedge with Willamette marks visible
