## Willamette # 7 Work Party Notes

### Historic Museum Fort Missoula, Missoula, MT

### 7/20/19 - # 6

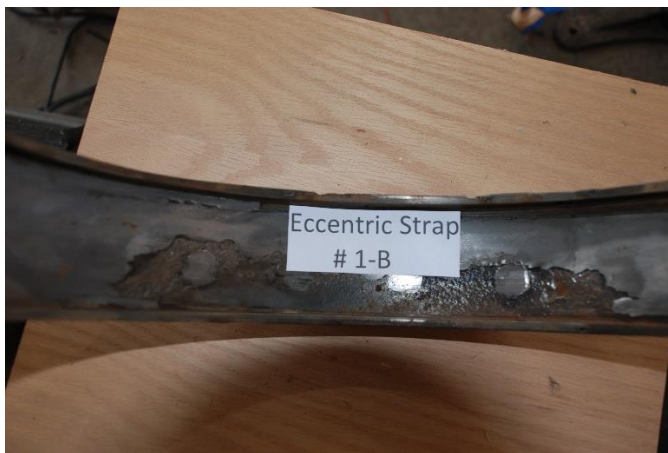
We removed the remaining eccentrics (# 1 had been removed and cleaned Work Party #5) cleaned the “straps” and bolts. The Eccentrics were Babbitt, it was in fair to poor condition. There were signs on moisture on the lower strap from exposure to weather as could be expected. The castings themselves were solid and no damage was noted. For the uninformed reader the Eccentrics could be considered similar to a cam shaft.

As noted Eccentric Strap # 1 Bottom

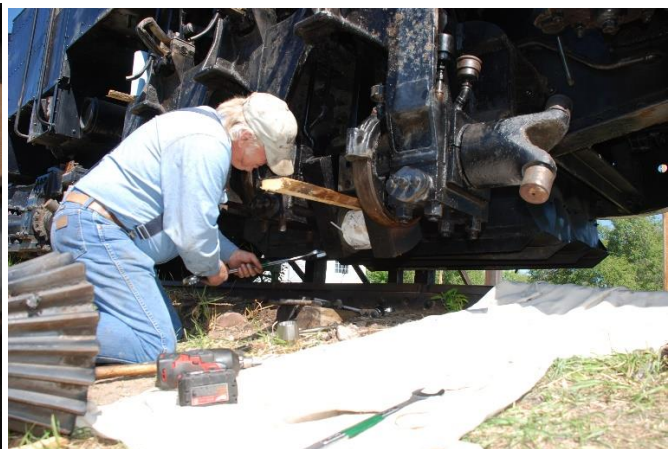
Undoing nuts on # 2 Eccentric Strap

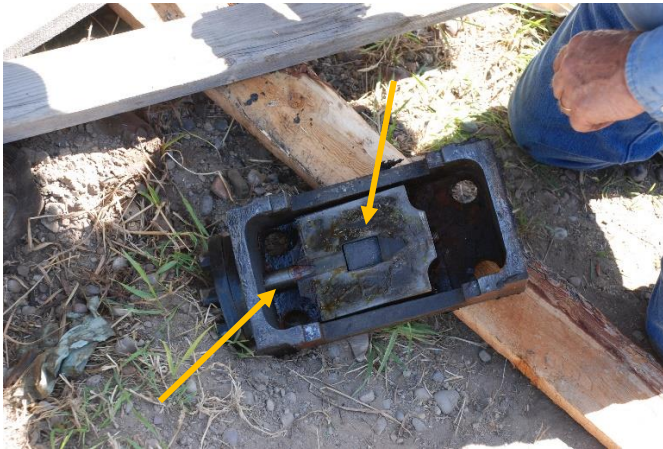
Lower the box and brass to the ground so that they could be removed from the locomotive. We noted a minimum amount of moisture in the boxes account of years of exposure to the weather. There was a little rust and no damage that could be detected. The rust was easily cleaned. The nuts (4) holding the boxes in place were 1 7/8" that were removed with a Milwaukee 18v Impact.

Box, wedge and adjustment nut and rod (yellow)

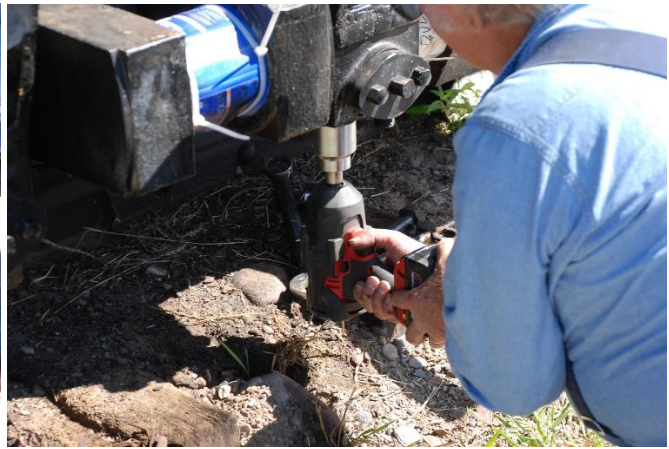
Impact removing Crank Shaft Boxes

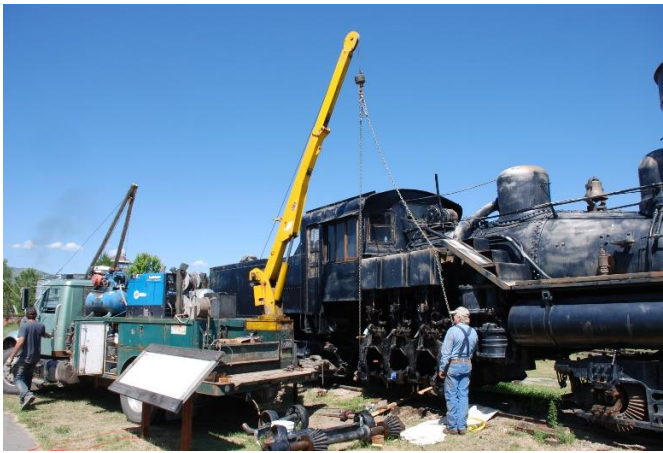
Rigging Crank to Crane for lifting

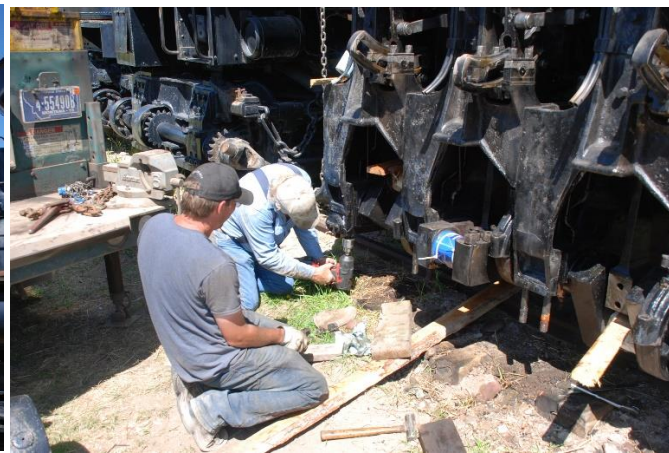
Unbolting # 1 prior to removal

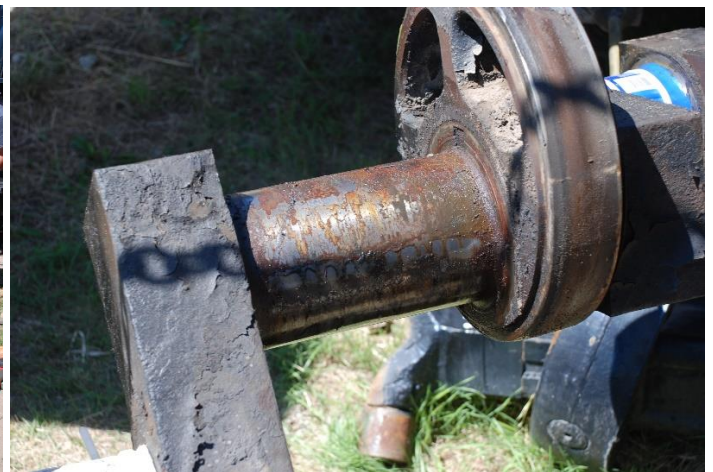
The crank shaft was moved to the back of the service truck as a “make shift” work bench. All journals, including Rod Journals were cleaned and inspected. We found rust and some affects of water (moisture) on the mains more so than on the rod brasses. These were all cleaned using emery cloth and a stone to polish the journal. The mains should allow limited operations. We will start a program of greasing and oiling on a regular bases to help preserve the work completed.

Journal # 2 prior to cleaning

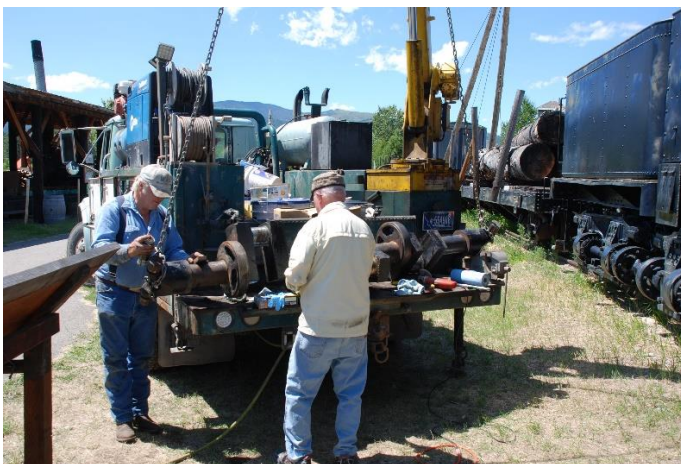
Crew cleaning crank journals

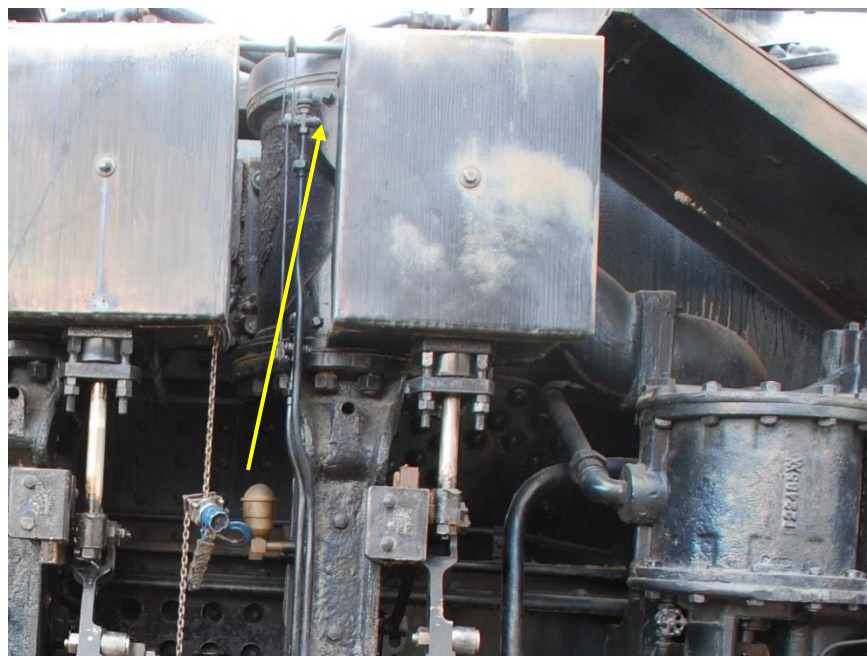
We removed the timing ports on all of the cylinders and used a “Bore Scope” to inspect the inside of each. We found no issues with the pistons, walls of the cylinders or the piston securing nuts on the piston rods. You could almost say they were “factory fresh”.

Timing/inspection Port
