Willamette # 7 Work Party Notes

Historic Museum Fort Missoula, Missoula, MT
7/22/19 to 8/31/19 - # 7 – A, B, C, D, E, F

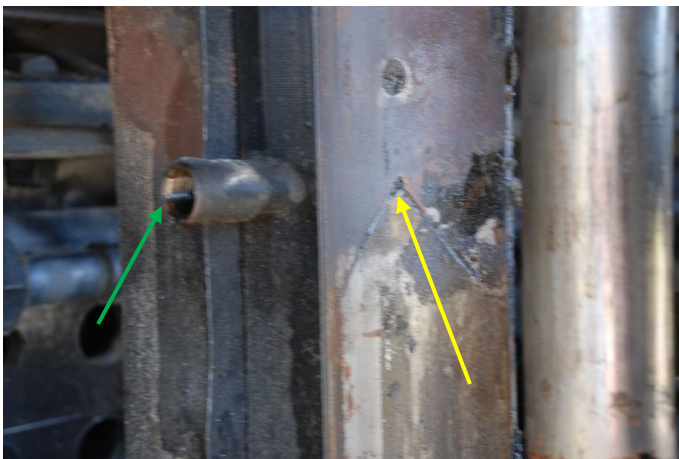
1 Gib (inside) prior to cleaning

On the locomotive the Crosshead “Gibs” were cleaned of old paint, primer and light rust. This was an on going process over several weekends due to the amount of paint. The piston rods were also done at this time. This was a process of using chemical paint striper (Ace Hardware) along with lightly scraping (as not to damage “bearing” surfaces). Then using a wire cup on an angle grinder, along with die grinder with wire brush to fit into the tight places. The oil holes in the gibbs were completely plugged with sand and oil congealed oil. These were leaned using compressed air and a wire to clean the passages. Oil flowed freely when complete. The crossheads were moved to complete the task by jacking and blocking.

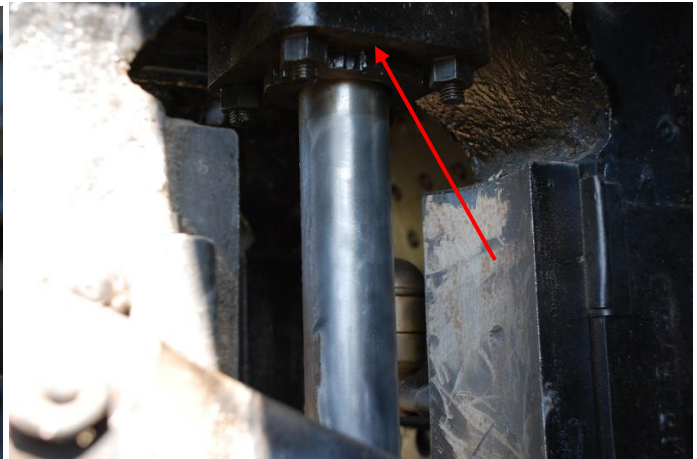
3 Piston Rod cleaning in progress

Yellow Arrow Shows Oil Galley Hole, Oil flows from cup with was removed from pipe shown at Green Arrow Packing Gland showing with Red Arrow. This gland contains the “packing” Paxton Mitchel Style the holds steam inside the piston on the lower side.

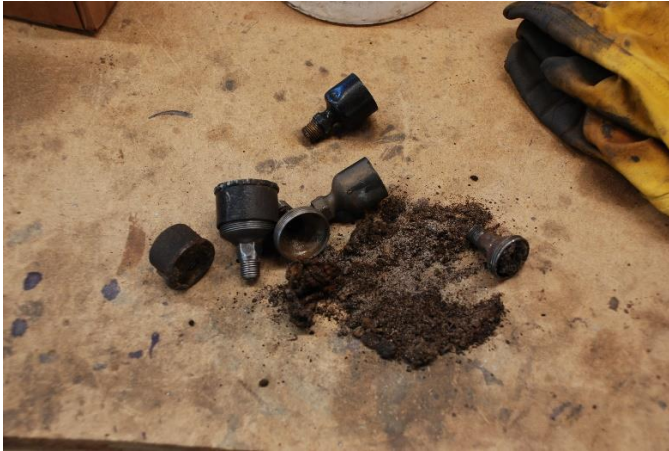
Oil cups, located on rotating surfaces were removed and it was found that twelve were missing. These were located at Flywheel Supply Co., and were found to be identical to the ones that Willamette used. These cups were originally for grease, but had been drilled in the top with a ¼" hole and packed with 100% wool yard to serve as oil cups. This is an acceptable use; it is not sure at this writing if this was a Willamette modification or by Heron or ACM. The remaining original cups were cleaned and reused. They were found to be completely packed solid with sand and oil so much so very little entered the bearing surface where they were used.

Gunk and Sand from Original Oil Cups

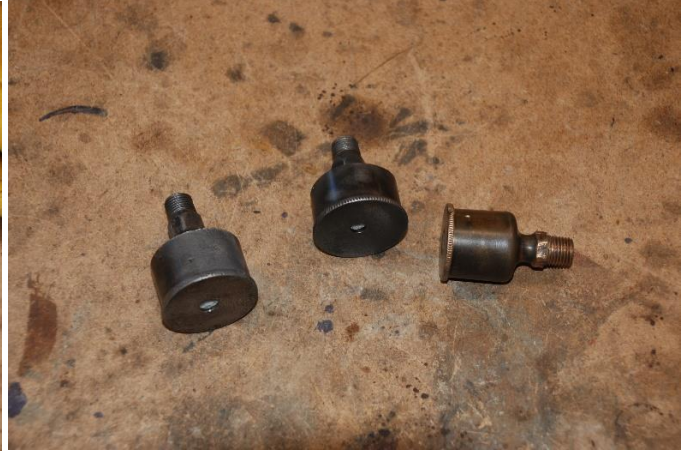
Original Oil Cups after cleaning

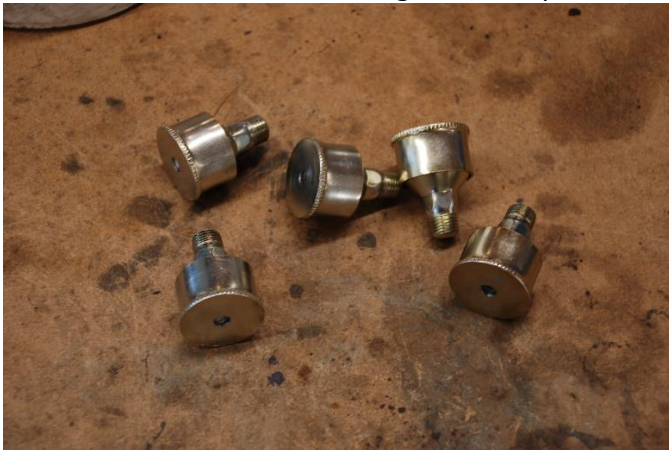
Replacement Oil cups modified and ready

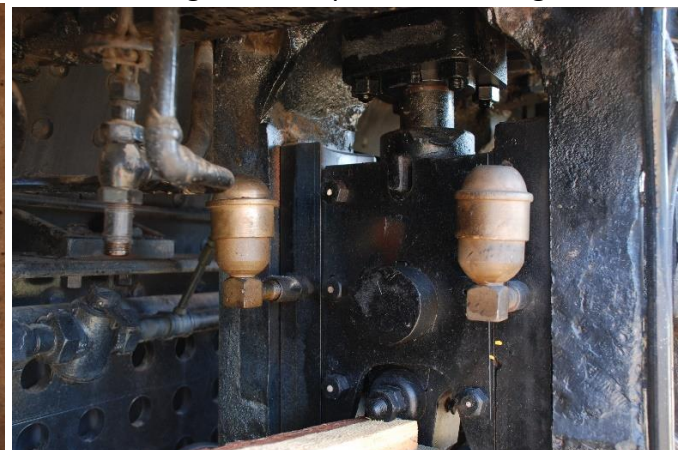
Larger Crosshead Oil Cups Cleaned and serviced

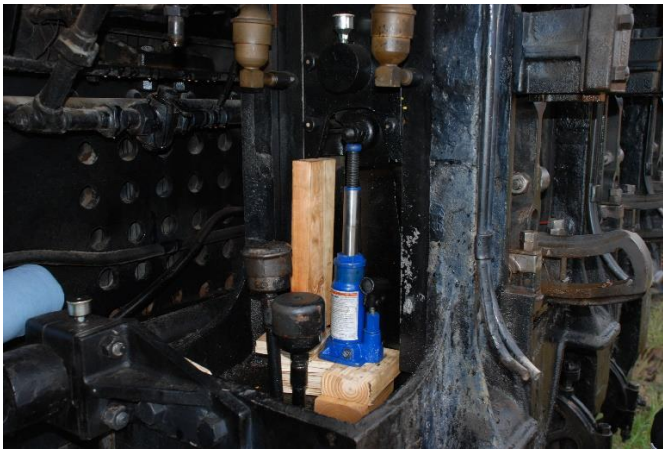
Jack Raising Crosshead and Connecting Rod

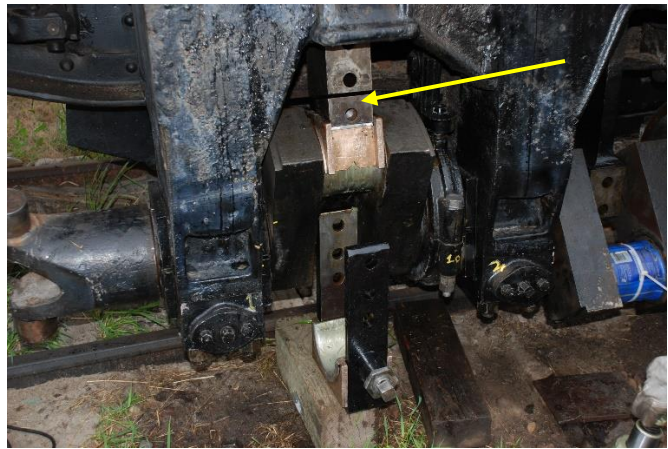
The rod straps (hold the bearing and the connecting rod assembly) were cleaned, inspected and qualified. The bearings had been previously cleaned and conditions noted (see Report # 5). The shims (on top and bottom bearings) were cleaned and inspected and new ones cut to replace # 3-T which were in poor condition. The straps were then reinstalled, using a bottle jack to lift the (with the lower bearing) into position on the crankshaft. The crosshead was then jacked up to allow room to install the upper bearing and wedge. The crosshead was then lowered to allow the bottom (butt end) of the connecting rod into the strap. Several (#'s 2 and 3) were too tight to fit onto the connecting rod. A threaded rod was used through one of the bolt holes with nuts on the inside to spread the strap and allow installation. This appears the way Willamette manufactured the straps, which are a forging. They were sprung about 1/8" to 3/16" and too heavy to move by hand.

Strap Ready to install Yellow Arrow is Wedge

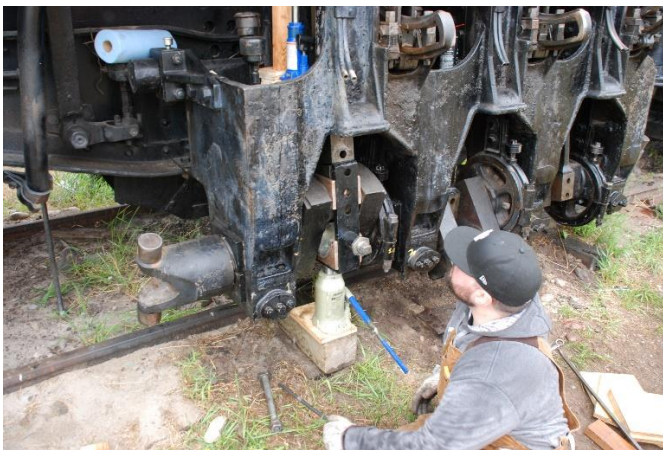
Jacking of # 1 strap into place

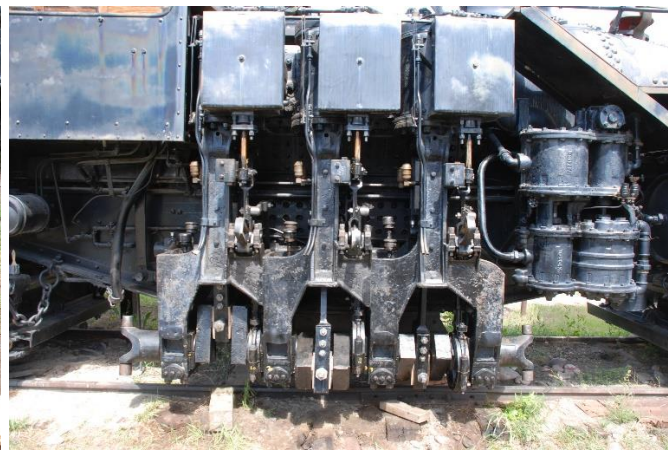
All straps and bearings back in place

Once all of the straps, bearings and connecting rods were in place and all of the bolts were torqued appropriately the crank shaft and the rod bearings were adjusted. This was done according to a July, 1923 reprint of Lima Locomotive Works Shay Instruction Sheet No. 3. As both Willamette and Shay used identical systems on the crankshaft and connection rods this was the best reference available.

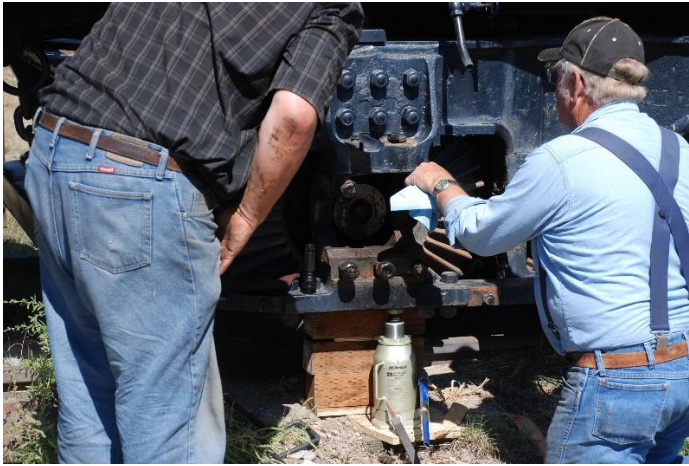
Jacking Truck/Cleaning Journal Box

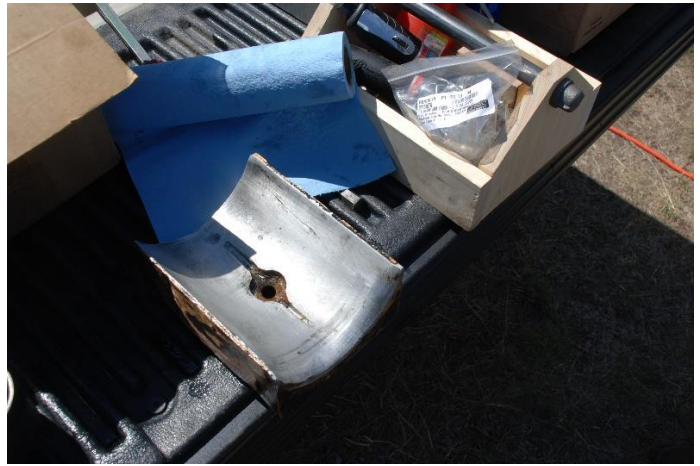
After a bit of cheering, we moved on to the trucks. We started on the Front Truck, Rear Axle, Right hand side. The truck was jacked up, with blocking under for safety. The packing was removed. This is Wool Yarn, need to be 100% wool so it is not affected by lubricating oils. The packing was dirty and show a very slight bit of moisture, which is to be expected as the oil gallery was/is exposed to weather, and most likely under snow at times. The bearing was removed cleaned and inspected along with the axel. Will need to make a puller for the other bearings 5/8"-14 Thread hole in the brass to pull them out.

Journal Brass after removal and cleaning

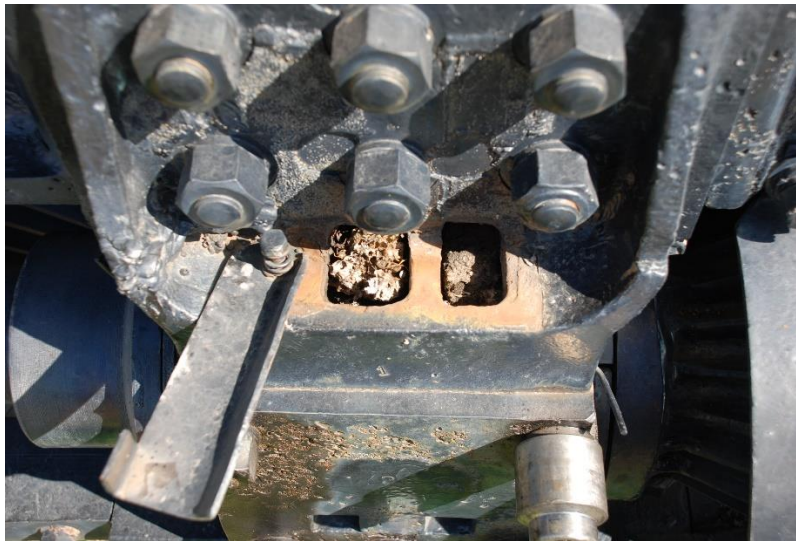
The journal box was also cleaned. Remaining to complete is the removal of nests (Bee's) and dirt from the oil gallery used to fill the boxes. In future Work Parties we will go through all of the bearings and axels on the three trucks.

Debris in Journal Oil Gallery prior to cleaning
