Willamette # 7 Work Party Notes 5/11/19

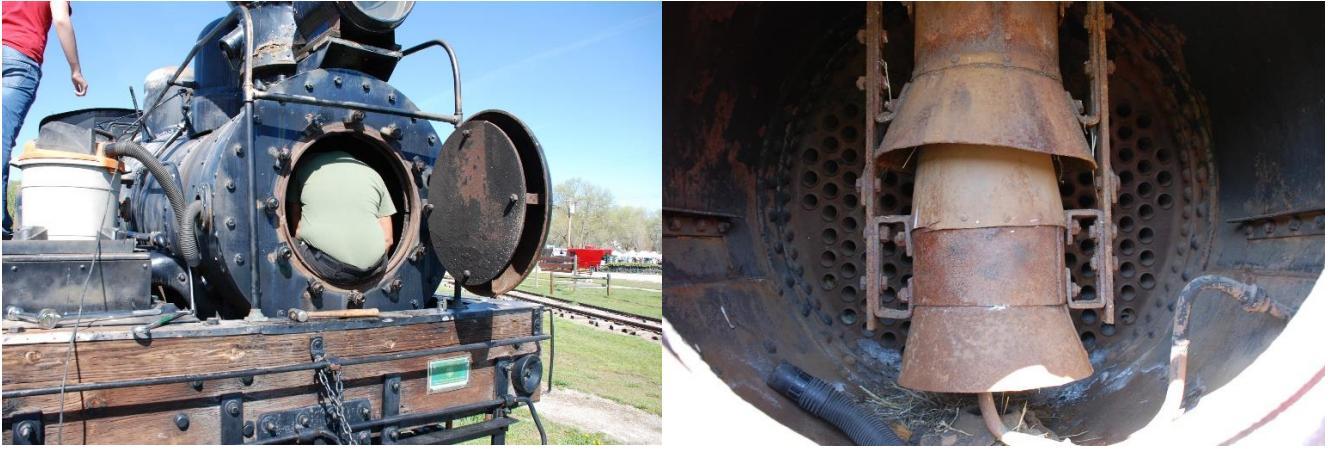
This is the first "real" work party at the locomotive. We opened the Smoke Box front and entered the Smoke Box and clean out all the debris. Initial inspection found all parts (Blast Nozzle, Blower Pipe and Petticoat Pipe) intact and serviceable. Found some metal debris that had fallen from the inside of the Radley Hunter Stack. The Front Tube Sheet along with all tubes were in place. The lower knuckle appears to be serviceable pending additional inspection and ultrasound. Noted that no door gasket was in place, and that "bird" were living in the stack.

Cleaning Smoke Box

Petticoat Pipe and Tube Sheet

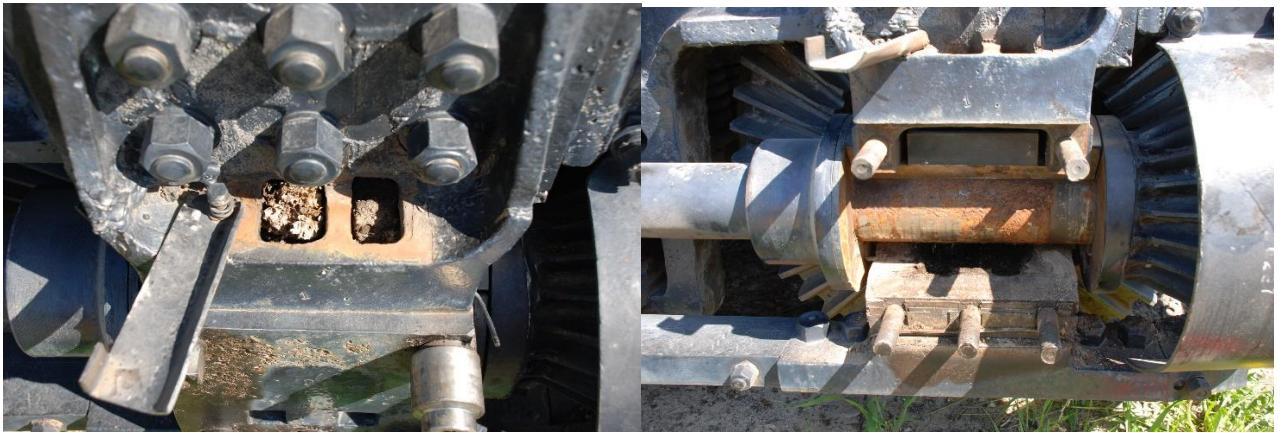
With the thought of rolling the locomotive to facilitate track repairs the crew turned attention to the running gear starting on the Engineer's side of the lead truck. It was noted that all of the oil passages were full of sand from earlier sandblasting operation along with nests from mud dabbers. We first removed the journal box cover plate and then the Line Shaft outside brass bearing half. It was noted that there was some pitting and water damage to the front bearing surface on the line shaft. We then removed the cover and bearing from Axel # 2, this end of the Line Shaft only had a "light" coating of rust which was easily removable. The front of Line Shaft # 1 is repairable. The drive line between the Front Truck and the "Engine" was also removed. It was noted that one of the "Horns" on the rear (engine end) of this driveline was broken and appeared to have been repaired in the past (poorly). This is repairable. The horn bearings are of steel after cleaning and polishing can be made serviceable again. All of the bearings and driveline parts were placed on a pallet and moved into the Saw Dust burner for safe storage. The two drivelines and Front-Line Shaft were placed on blocks next to the locomotive with bearing services greased for protection.

Sand and Debris in Oil Passage

Front Line Shaft with Bearing Removed

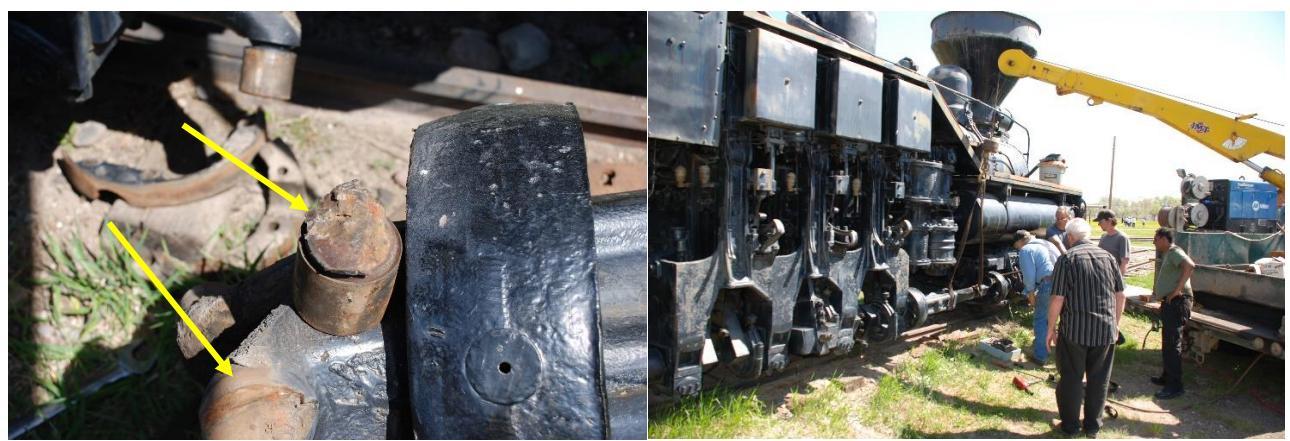
Rear of Driveline Showing Broken Horn

Crew Removing Line Shaft

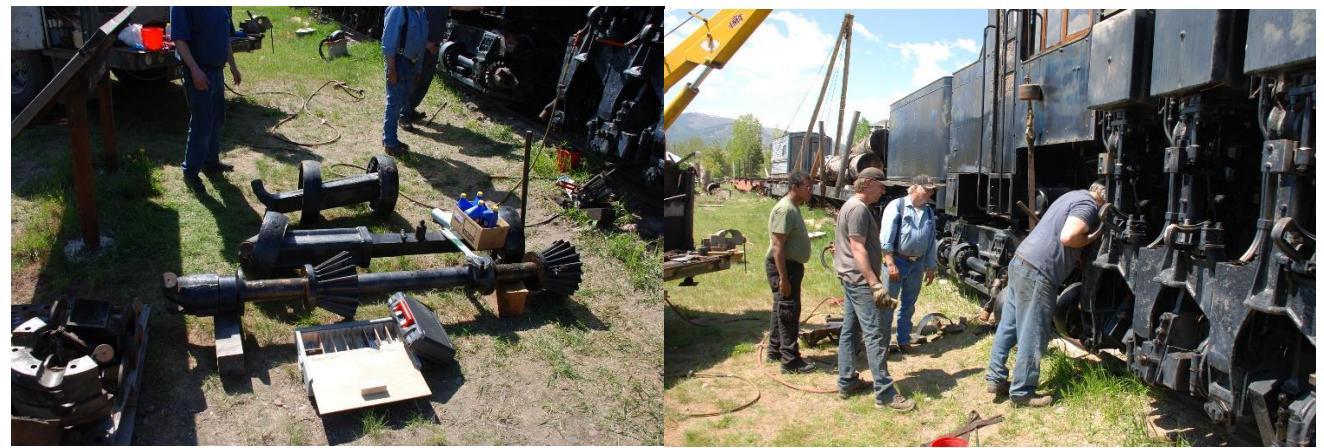
Line and Driveshafts off locomotive

Crew inspecting and planning next move

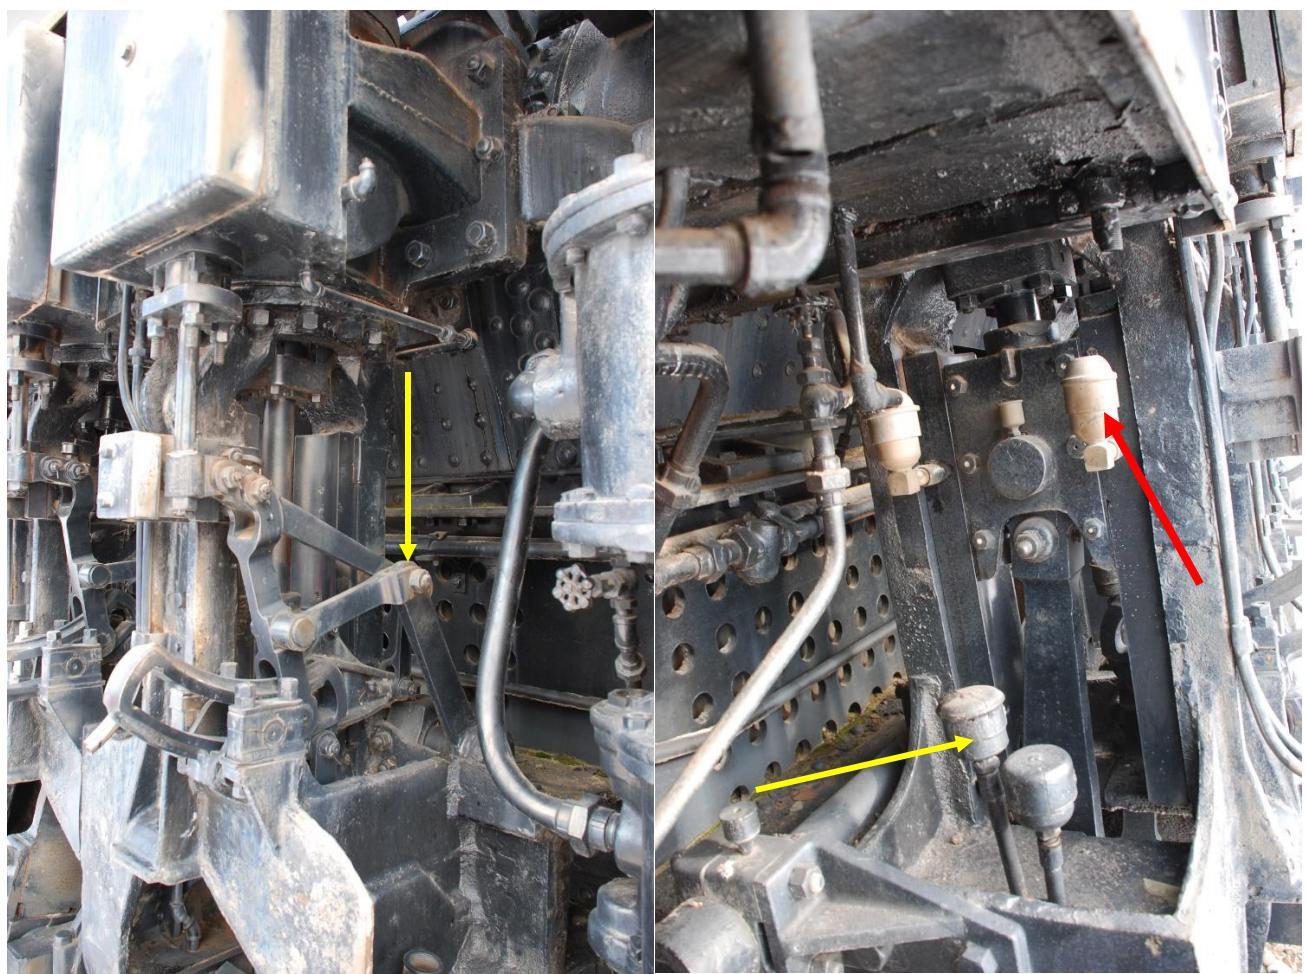
We removed the top cover metal plate which had been welded previously over the engine. This plate as built should have been hinged to fold up out of the way for servicing. The original hinges were on the plate but had been cut at a previous time. We found plugs into the top of the cylinders (1/2 NPT) which were removed and lubricating oil was sprayed into each cylinder. We will let that soak for a time. Grease plugs were removed from the crankshaft rod ends and the old grease removed. New grease was installed, the bearings took lubrication freely.

Tumbling Shaft Pin prior to cleaning

Oiling Points Removed and Cleaned
