Willamette # 7 Work Party Notes Historic Museum Fort Missoula, Missoula, MT 7/9/19 to 7/18/19 - # 5

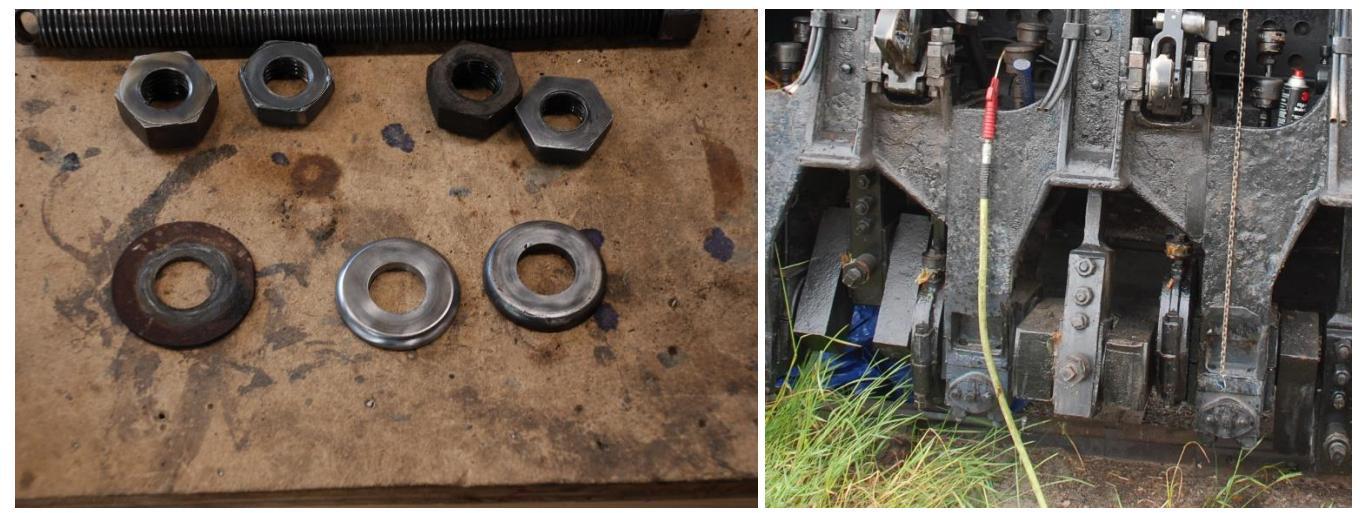
Finished cleaning nuts and threaded adjustment rods for main rod wedges. Found one or three threaded rods was missing back side washer which was replaced in the past with a standard flat washer. Made a new washer the same as original Willamette washer by coping the existing original. Took the rod straps to engine rebuilder to have "hot tanked". Cleaned and checked all the threads on the straps and removed remaining rust from the inside. Painted the straps.

Flat Washer (L), New Copy (M), Original Willamette (R)

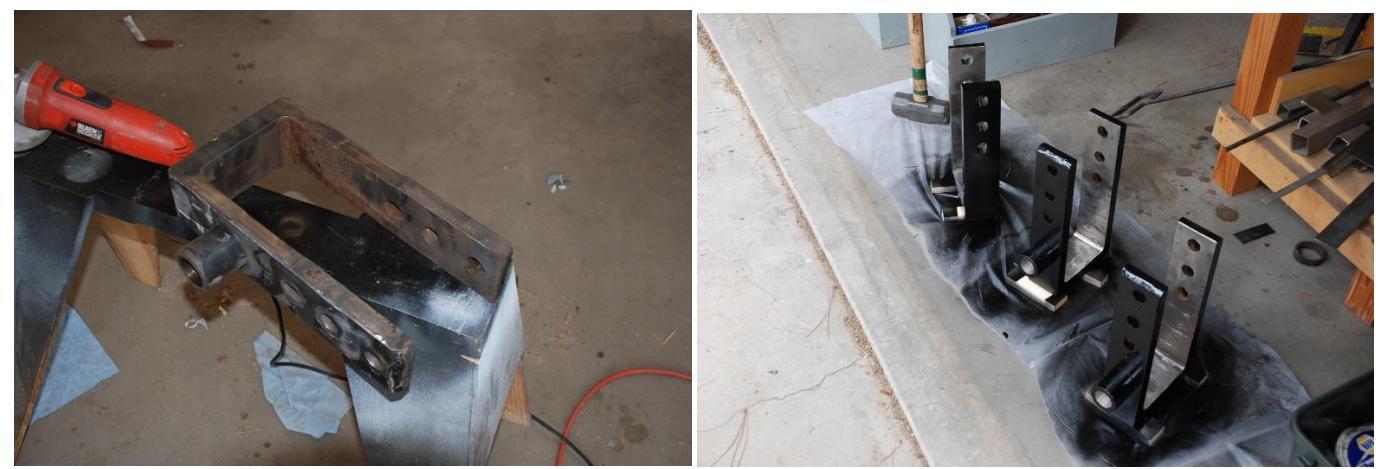
Rod Strap Prior to removal

Rod strap prior to cleaning and painting

Rod Strap completed and qualifyed

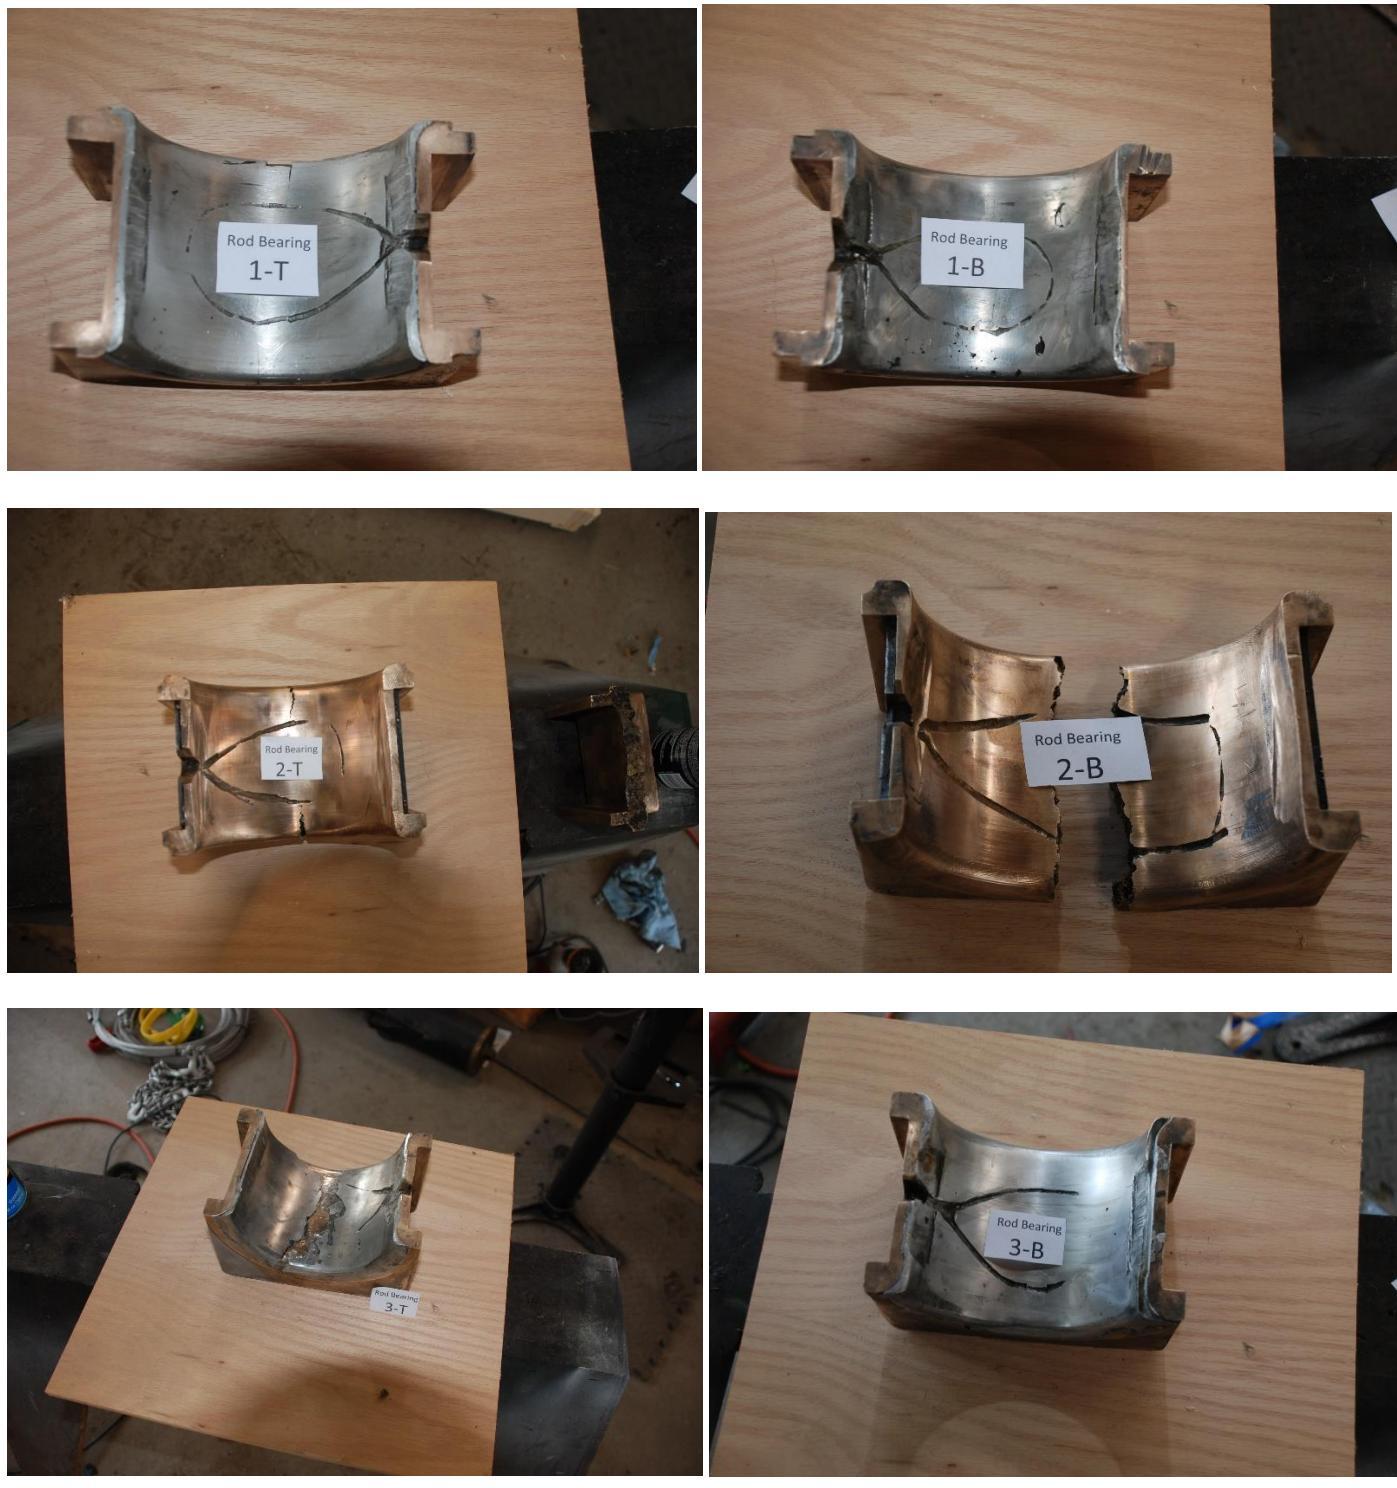
Pictures for Reference of all Rod Brasses

The "split half" Rod Brasses had been previously removed by us in the last Work Party. They were cleaned, and inspected. It was noted they were stamped as to location most likely by Willamette by possible by Anaconda as they showed signs of having been removed a number of times in the past. Willamette used number to indacate the cylinder position and "T" for top and "B" for bottom. Noted that the brasses were in poor to fair shape, servicable for limited use, but several will need to be replaced in the future. Conditions are listed as follows:

1-T Good Condition; Babbitted surface (not original) most likely by Anaconda to save cost of new
1-B Good Condition; Babbitted surface (not original) most likely by Anaconda to save cost of new
2-T Fair Condition; Original Brass Surface but partely cracked – Canidate for replacment
2-B Poor Condition; Original Brass Surface but broken in half – usuable canidate for replacment
3-T Poor Condition; Babbitted surface (not original) Babbitt needs replacing or canidate for replacment
3-B Good Condition; Babbitted Surface (not original)

Should be noted that making new brasses is a rather simple process that included making a wooden pattern, finding a foundry to cast the part (generally out of 80-10-10 Bronze), and some machine work on the finished casting. In reviewing the Willamette files which cover the parts ordered by Western Lumber, Heron Lumber and Anaconda indicate that one Crank Pin Brass (Part # RRDSC A-3) was ordered with a "5 Bore on 10/5/1940. That drawing is on

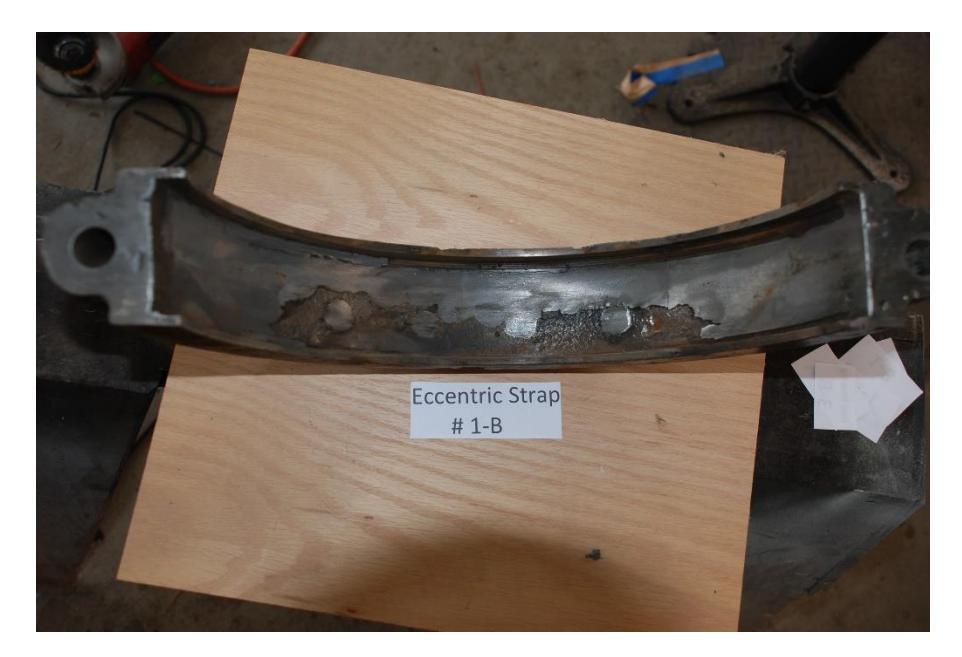
I removed the Eccentric Strap and cleaned the same. It's "running' surface has been babbitted at some point and broken in number of places (babbitt). The strap is still servicable and had some rust on the lower point due to water collecting from sitting.
