Willamette # 7 Work Party Notes Historic Museum Fort Missoula, Missoula, MT 9/14 & 28 10/12/19 - # 8, 9, 10

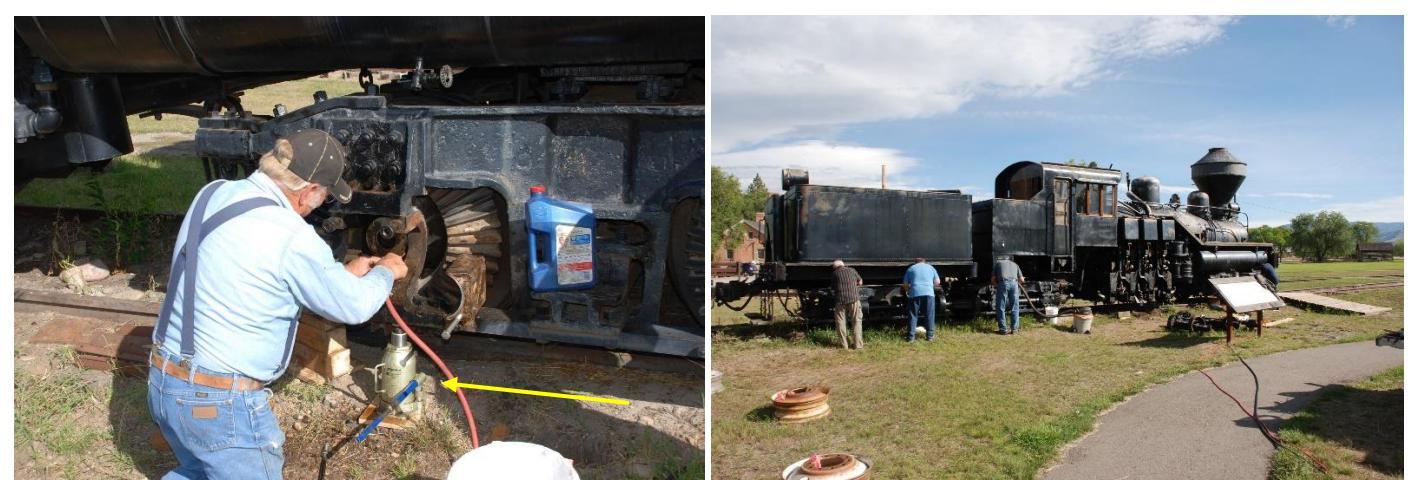
Jacking and removal of Brass # 2R note jack

Crew cleaning oil galleries trucks # 2, # 3

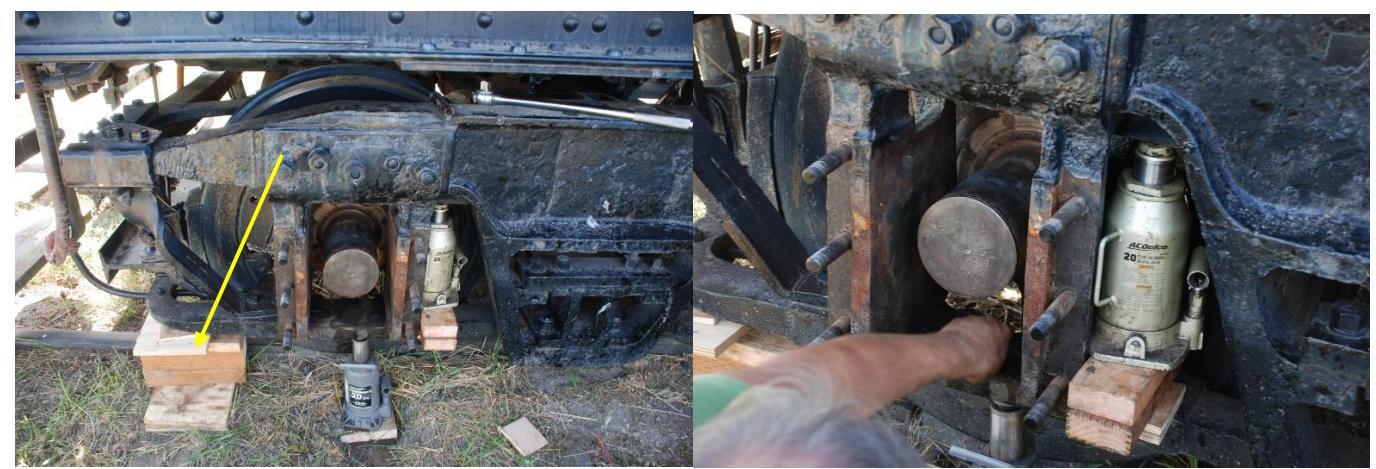
what Willamette refers to as the "Inside Box" which in reality is a journal box. This required a placement of an additional 20-ton jack inside the frame to jack the beam. We did one axel at a time. Also found that axel # 1L show the most ware, due to being the lead axel and "attacking the curves" along with being the most exposed to the elements.

Jacking # 1L "Safety Cribbing" under truck

Jack lifting equalizer beam

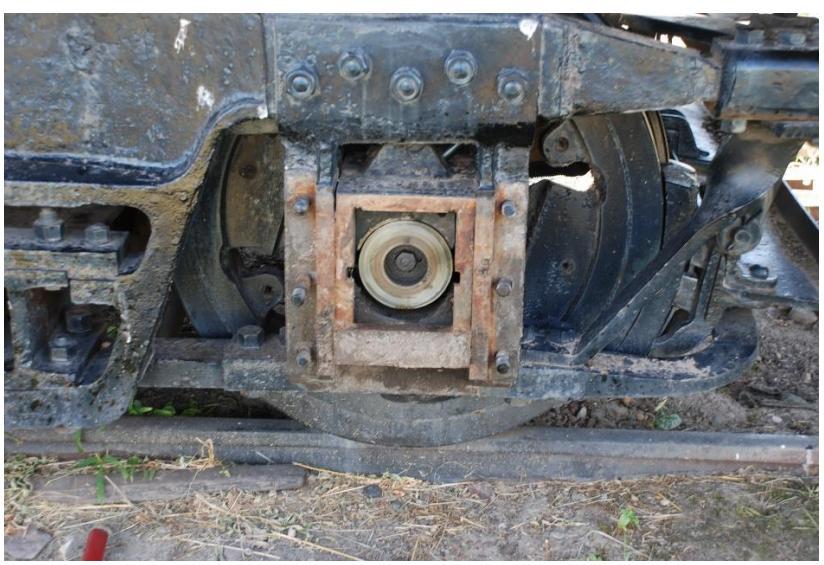
Axel # 2L after removal of pedestal cap

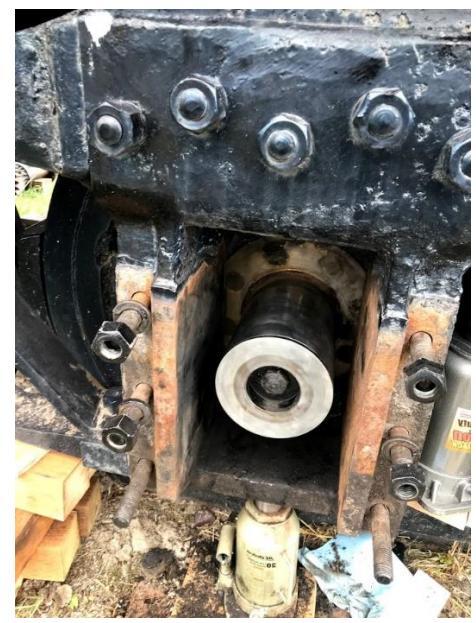
Axel # 2L cleaned pedestals need cleaning

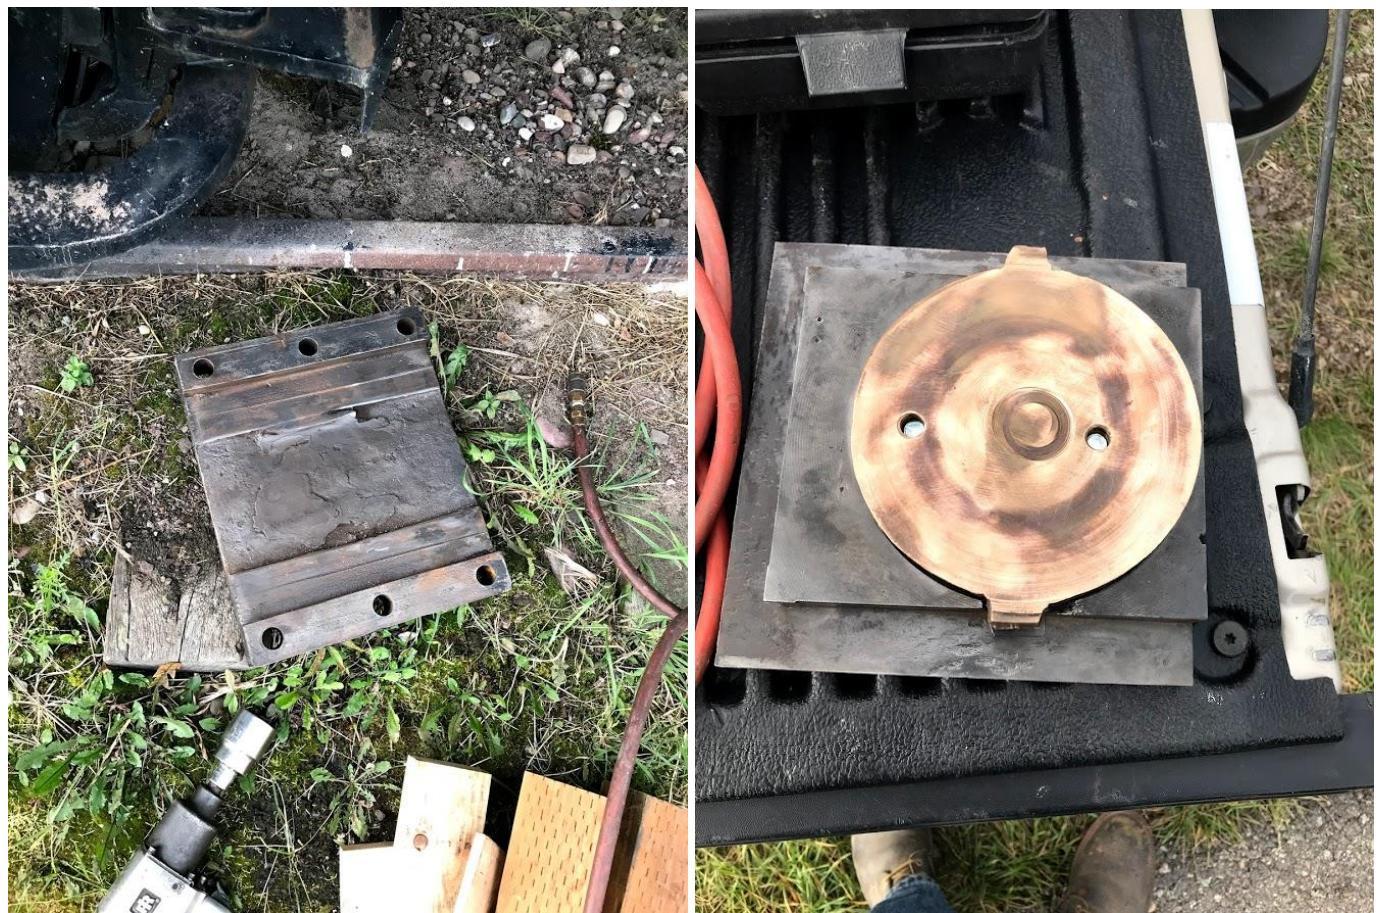
The Truck on the left side journal consists of Inside Box (discussed above), journal brass (bearing), inside box cap, which has a thrust plate (brass) bolted to it with ½-13 bolts and the pedestal cap. We found both of the thrust plated at one broken or missing bolt (2 total bolts per plate). The holes for these bolts are threaded in the brass thrust plate and were "chased" with a tap and found to be in good condition. The missing bolts were replaced with like kind. The pedestal caps (cover plates) had a number of shims, this is to set the "back lash" of the gears on the right side. Careful note was made of the number of these shims and they were installed as found.

Outside Plate (pedestal cap) cleaned for installation Inside plate with thrust plate bolted together

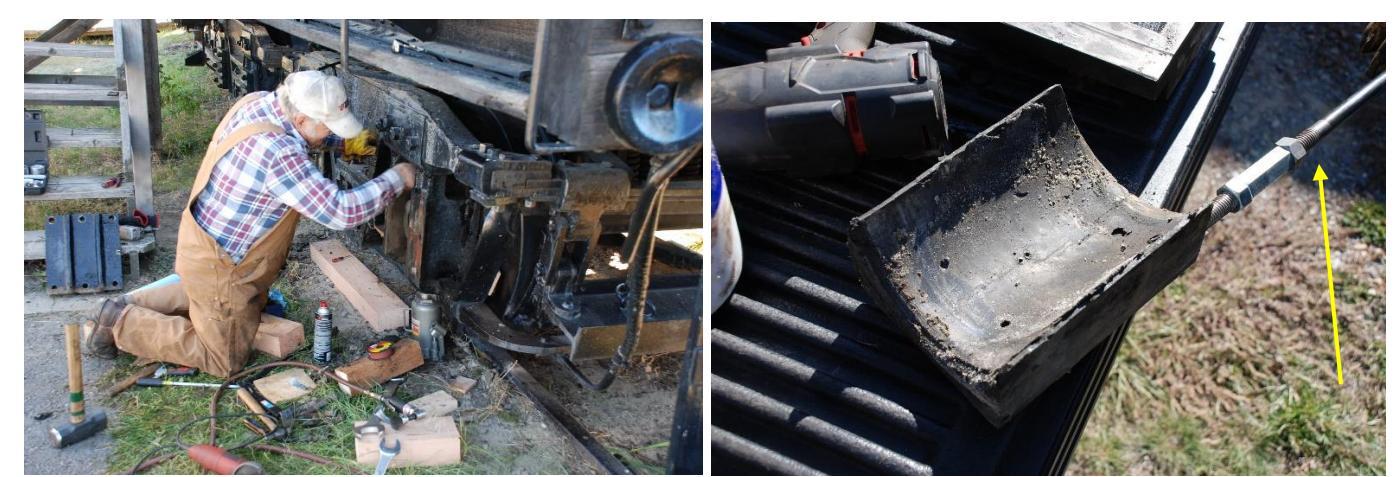
Working on axel # 6L

5L Brass after removal note puller tool

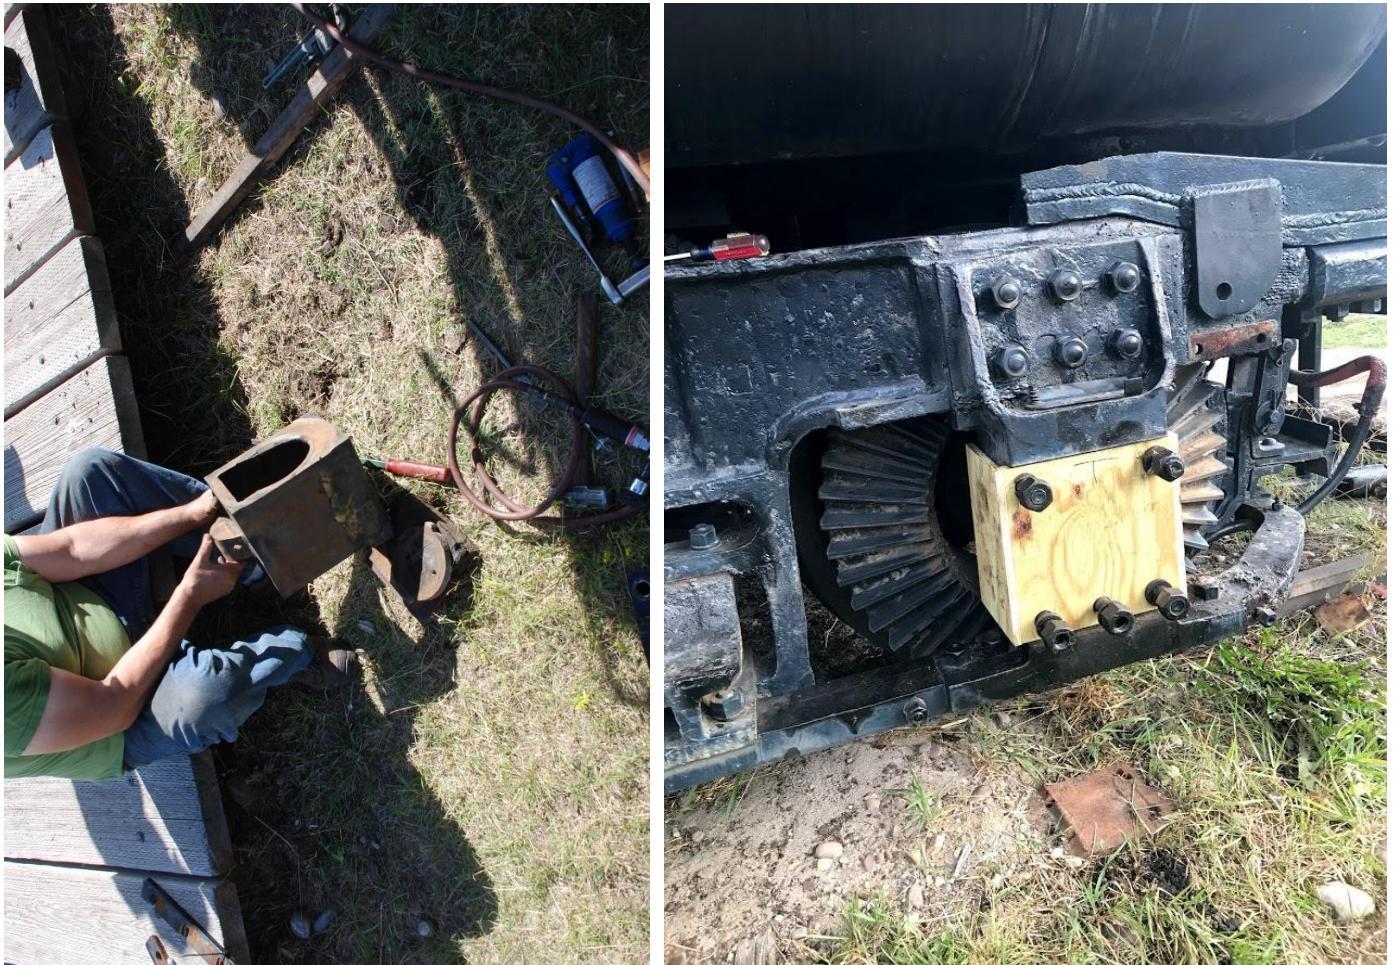
Plywood cover (weather protection) # 1R

Inside Box (Journal Box) ready to be cleaned

Additional work was completed to "winterize" the locomotive. Plywood Boxes were constructed to cover the right-side journals and installed on the # 1 truck. A tarp was secured over the cylinders and works to protect it. Everything was well oiled. We expect that we will have limited working days left prior to winter so are trying to get a lot accomplished.
