Willamette # 7 Work Party Notes

Historic Museum Fort Missoula, Missoula, MT

6/8/19 to 6/12/19 - # 2 – 2A

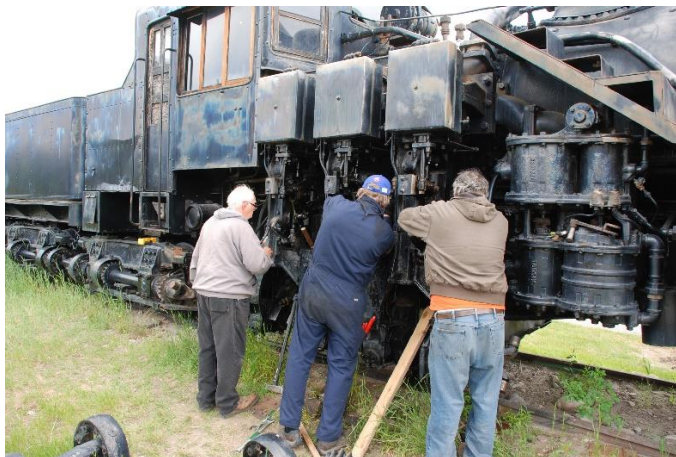
Crew working on valve Gear

We removed the plugs on all three lubricating lines to the valve chests and sprayed in penetrating oil, same as was done on the pistons through the timing ports on the previous work party. Made a cover for main crank bearing # 4 which was missing and installed. Added lube oil to all points on the locomotive. We have not as yet installed new wool packing yarn to the oil points. We are wanting the oil to flow freely into all bearing surfaces.
