Willamette # 7 Work Party Notes Historic Museum Fort Missoula, Missoula, MT 7/9/19 to 7/18/19 - # 5

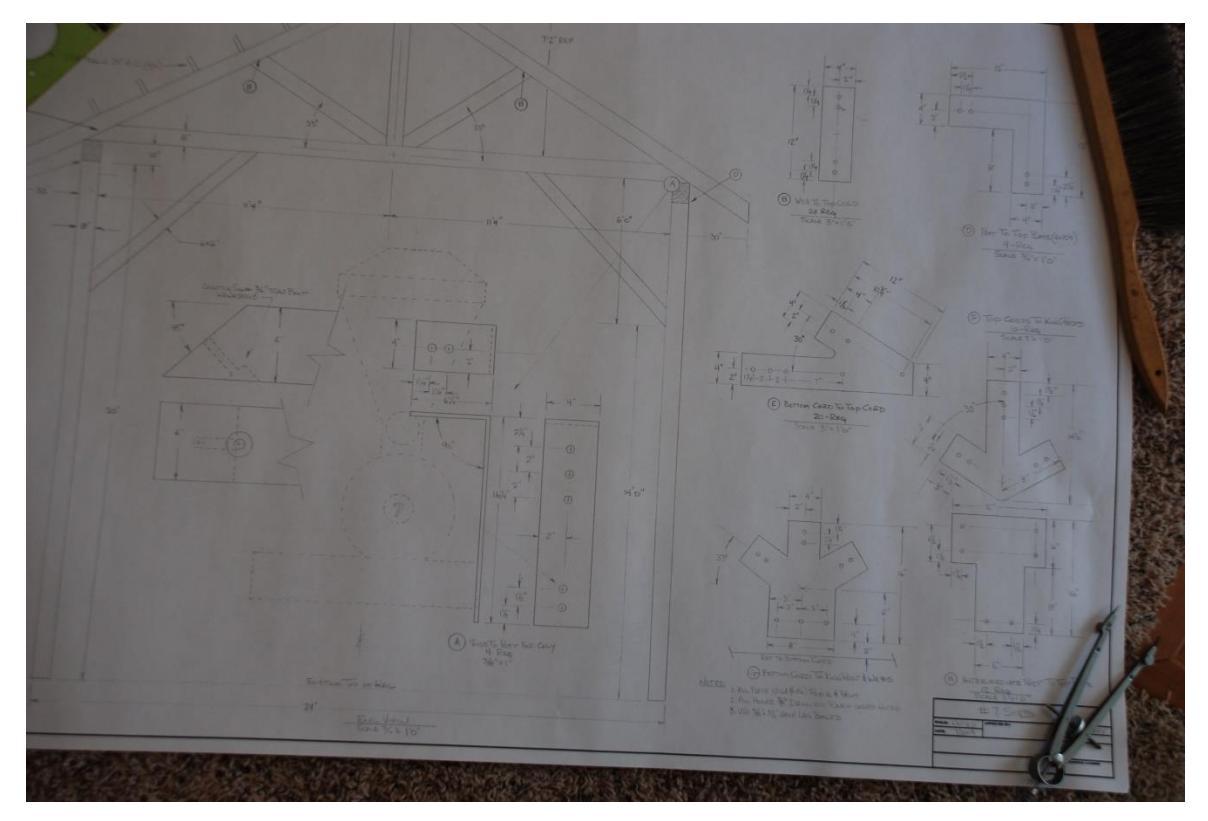
Complete designing a structure to cover the # 7, designed to represent a timber structure of the "era" with a flare of heavy industrial look in the metal brackets used in joining the timbers. Since I am not a Structural Engineer, these were turned over to Mark Buck to review and to be placed in a format that the City of Missoula will approve.
