## Willamette # 7 Work Party Notes

### Historic Museum Fort Missoula, Missoula, MT

### 7/20/19 - # 6

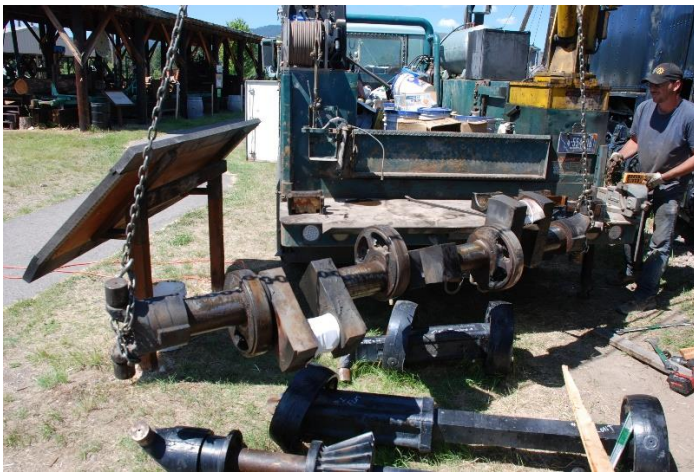
The crank shaft was moved to the back of the service truck as a “make shift” work bench. All journals, including Rod Journals were cleaned and inspected. We found rust and some affects of water (moisture) on the mains more so than on the rod brasses. These were all cleaned using emery cloth and a stone to polish the journal. The mains should allow limited operations. We will start a program of greasing and oiling on a regular bases to help preserve the work completed.

Swing the crank to the back of service truck

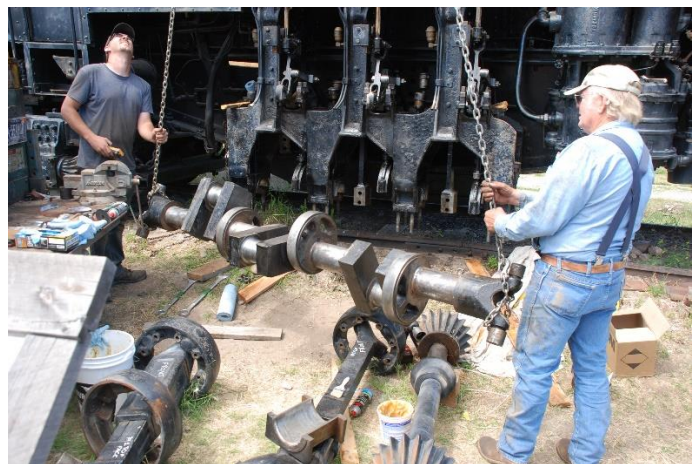
Returning crank to locomotive

The crank shaft was reinstalled on the locomotive again using “old school” methods to press the boxes into position for bolting. The mains were not adjusted, but left loose until the next work party. All parts were well lubricated prior to installation. The mains use oil (30SAE Machine Oil) filled from the top by larger oil cups (3 per journal). We still need to place new “Wool” packing in the cups. This is regular (not dyed) wool  
(6-3)

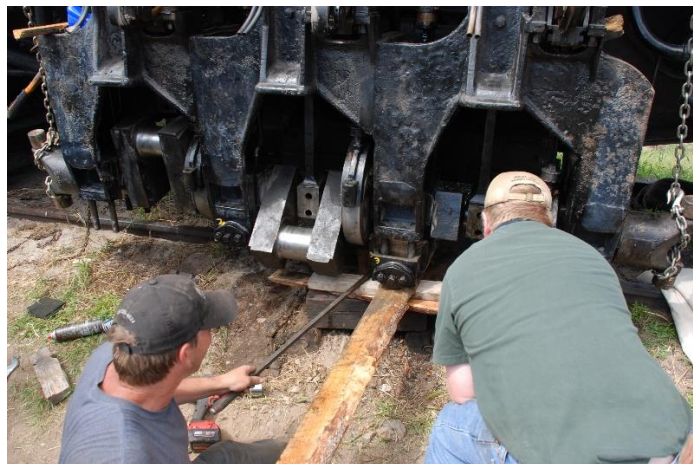
“Old School” installing boxes

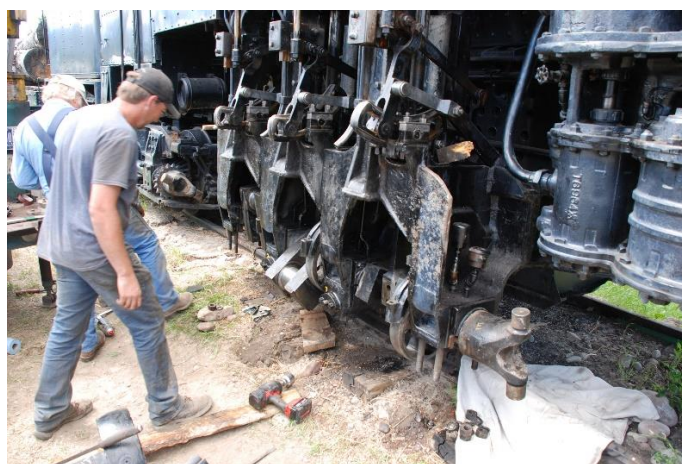
Crank Shaft Back in place
